# **Phase I ESA of E-PLA, Netherlands**

**March 19th, 2010**

| <b>Project number</b> | 4698857 |

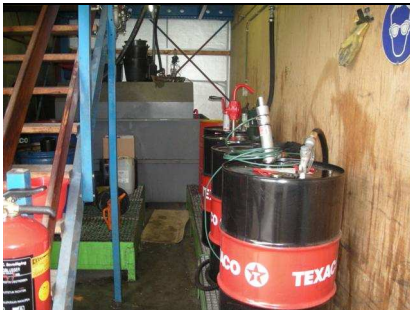
Hydraulic oils and lubricants were observed to be stored in one of the corners of the production building. Hydraulic oils and lubricants were stored in a number of six drums located on secondary containment. Waste oils were stored in a double-walled aboveground storage tank with a capacity of 3,500 litres. Flooring in the area was observed to be of concrete and in good condition, however housekeeping could be improved in this area considering the staining observed here.

**Figure 2.2 Oil and lubricants storage and storage tank in the back**

- Housekeeping in the oils and lubricants store could be improved. This concerns a housekeeping issue of no material concern.

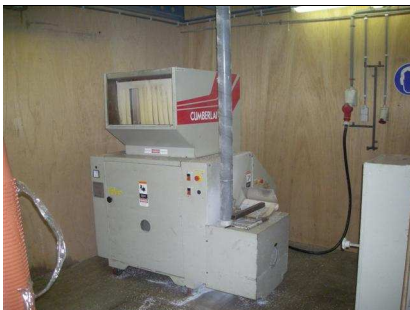
The ventilation system of the recycling machines was observed to be a potential major dust emission source, however the ventilation is fitted with a cyclone that was constructed to ventilate indoors instead of to the outside. This cyclone is equipped with dust collection bags.

**Figure 2.3 Plastics recycling equipment**

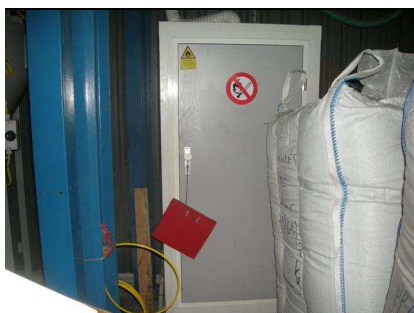
A dedicated storage facility was used for the storage of hazardous maintenance and cleaning products. Quantities of these products were limited to approximately 100 litres and material Safety Data Sheets of the products were in place.

**Figure 2.5 Hazardous substances storage facility**

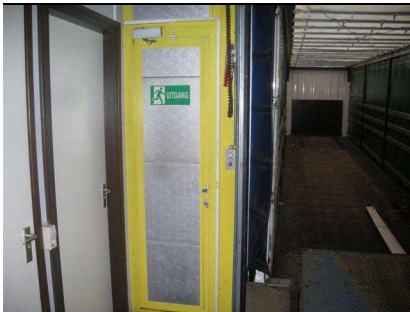
The site has space constraints and as such a number of emergency routes were observed blocked. For best practices, emergency routes should be kept free at all times and emergency exit signs should be upgraded to illuminated signs (refer to Appendix 2, pictures 2.10 and 2.11 to obtain an impression of the current state). Associated costs are minor.

**Figure 2.9 Substandard fire door – 1 (no illuminated exit sign - best practice issue)**

- For best practices, emergency routes should be kept free at all times and emergency exit signs should be upgraded to illuminated signs. Associated costs are not material.

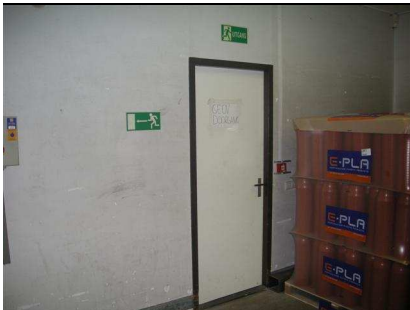
**Figure 2.10 Substandard fire door - 2 (no illuminated exit sign - best practice issue)**

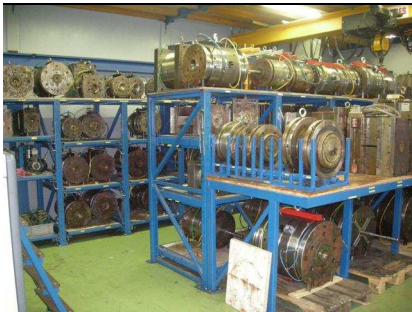
- A mould storage facility, a freestanding construction of wooden frame connected to the main production facility by means of a corridor (refer to Appendix 2, pictures 2.18 and 2.19). Site management reported to be willing to replace, enlarge and improve this facility however is awaiting the renewal of the municipal zoning plan

**Figure 2.17 Inside of the moulds storage room**

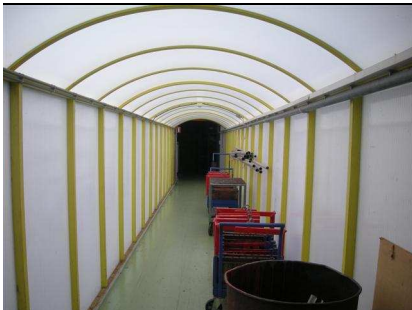
- ▶ Moulds were observed to be stored in a room constructed of combustible materials. This freestanding room is connected with the main facility through a corridor constructed of hard-plastic sheets which could act as a conduit spreading fire and soot in case of a fire incident in one of both areas. It should be considered to remove the corridor, or alternatively, to construct a proper fire door.
- ▶ It should also be considered to remove wood blocks that are stored in the adjacent privately used greenhouse, as these blocks can be a source of fire incidents or may spread fire in case of an incident somewhere else.

Furthermore, moulds were observed to be stored in a room constructed of combustible materials. This freestanding room is connected with the main facility through a corridor constructed of hard-plastic sheets which could act as a conduit spreading fire and soot in case of a fire incident in one of both areas. It should be considered to remove the corridor, or alternatively, to construct a proper fire door.

**Figure 2.18 Corridor constructed of hard-plastic sheets from the main building to the moulds storage room**

Site management stated to be willing to replace the moulds storage facility by a larger and more dedicated storage facility, but to be awaiting the formal approval of a new zoning plan for the area (expected in 2011) as the current zoning plan does not allow further extension of constructions on site.

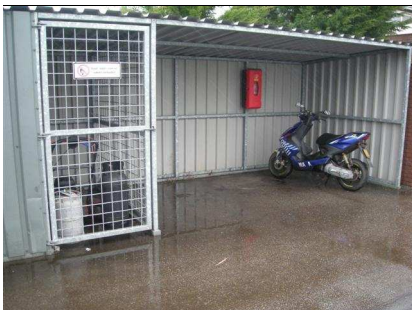
A small gas storage facility was constructed outdoors and was observed to contain two gas bottles most likely containing LPG and propane.

**Figure 2.19 Shed with gas cylinder storage**

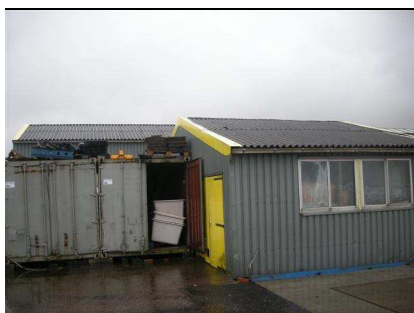
No asbestos survey or inventory was available for review and none is required in the Netherlands. Site management was not aware of the presence of asbestos containing materials, apart from corrugated roof sheets that are suspected of containing asbestos. These roofs were observed on the moulds storage facility and the neighbouring small shed and were estimated to cover a total area of 200 m<sup>2</sup>. The materials were observed to be in good condition and as such, health risks associated with the release of asbestos fibres are not anticipated as long as the material remains untouched (refer to Appendix 2, pictures 2.22 for an impression).

**Figure 2.21 Suspected asbestos roofing on the barn and the moulds storage room beyond**

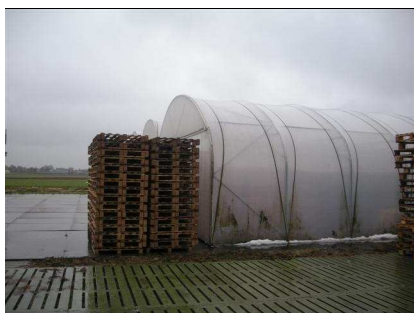
As formal non-compliance issue, however not anticipated to have practical or legal impact on the site operations, the unauthorised storage of finished products in the greenhouse tunnels was identified.

**Figure 2.23 Tunnels used for storage of finished products**

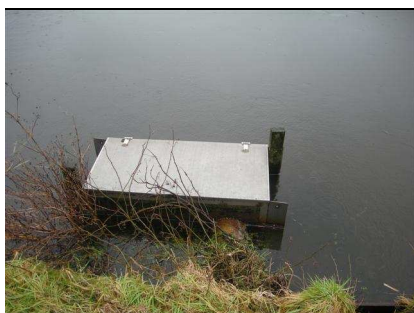
Storm water from the roofs and outdoor paved areas is discharged onto the neighbouring surface water passing filter boxes to trap plastic granules.

**Figure 2.25 Filter box for capturing granules discharged through storm water**

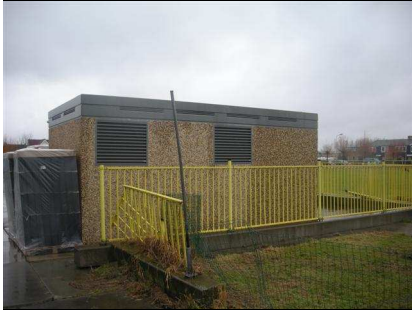
Transformers are present in a transformer house adjacent to the facility. According to site management, the transformers were installed in 2005 and are maintained and managed by the electricity company. Considering the construction period of both the transformers and the injection moulding machines, it is considered unlikely that PCB containing (cooling or hydraulic) oils is present in one of these installations.

**Figure 2.28 Transformer house**

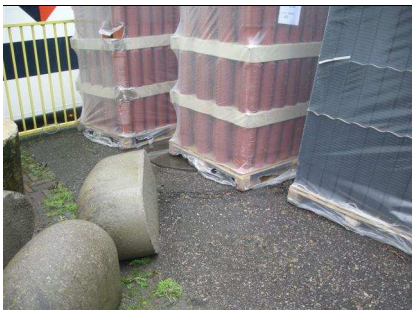
The site obtains approximately 200 m<sup>3</sup> of drinking water from the public mains. Waste water is discharged into the municipal sewer system, passing an oil separator. No waste water measurement data were available and none are required.

**Figure 2.31 Oil separator (see iron lid under pallets with orange coloured plant pots)**
