Fire resistance test on a non-loadbearing uninsulated external wall construction covered with a single layer of Cembrit Multi Force boards on the unexposed side and Cembrit Construction façade boards on the exposed side

Test method: Standard EN 1364-1:2015 "Fire resistance tests for non-loadbearing elements – Part 1: Walls"

Requested by: Cembrit Production Oy

Test Date: January 22, 2016

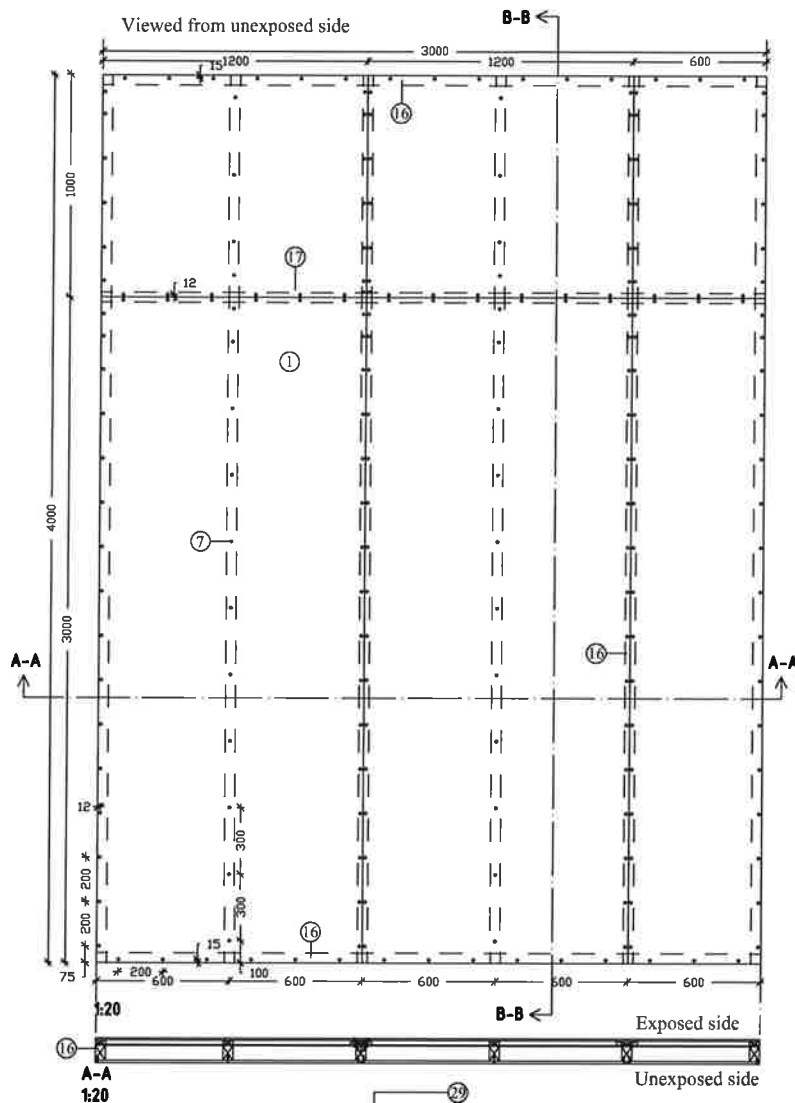
Screw/nail principle for joints solution (unexposed and exposed side)

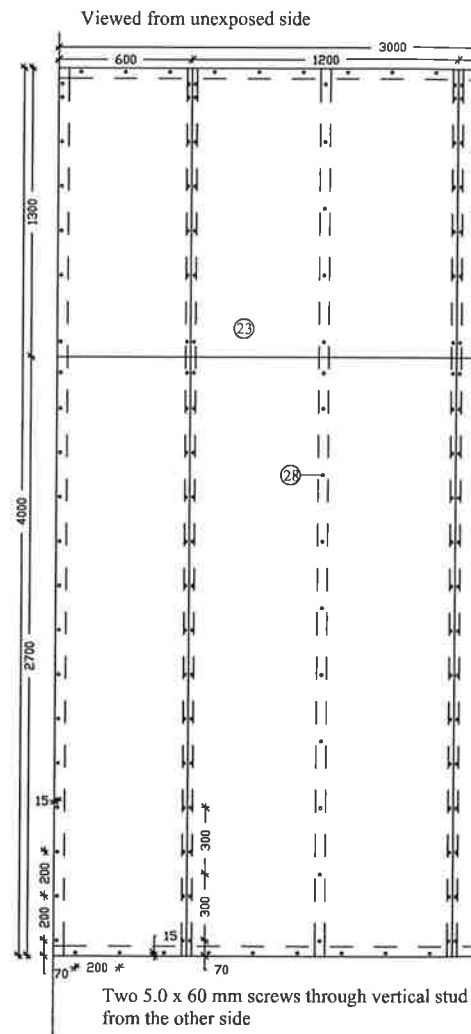
Two 5.0 x 60 mm screws through vertical stud from the other side

- ① 12 x 3000 x 1200mm Multi Force, long sides of the board are rec
- ⑦ Steelscrew Li-SW/S 4,2x35 mm.
- ⑬ Woodframe 45 x 66 mm.
- ⑰ Horizontal transoms between vertical woodframes, 45 x 66 mm
- ⑲ Cembrit Windstopper Extreme 4,5 x 1200 x 2700 mm.
- ⑳ Cembrit Construction 8 x 1200 x 3050 mm.
- ㉑ Wood plank 20 x 95 - 20 x 45 mm

Test specimen was a non-loadbearing external wall construction (b x h = 3000 x 4000 mm) comprising of six vertical 45 x 66 mm timber studs c/c 600 mm and 45 x 66 mm timber battens as the head and floor tracks and behind the horizontal joint between the vertical studs. The head and floor tracks and one vertical edge stud were fixed to the concrete frame with Gunnebo screws (5.0 x 90 mm). Vertical studs were attached to the head and floor tracks with two 4.2 x 45 mm screws at each end. Horizontal studs were fixed to the vertical studs with two 5.0 x 60 mm screws through the vertical timber stud and one 4.2 x 54 screw diagonally.

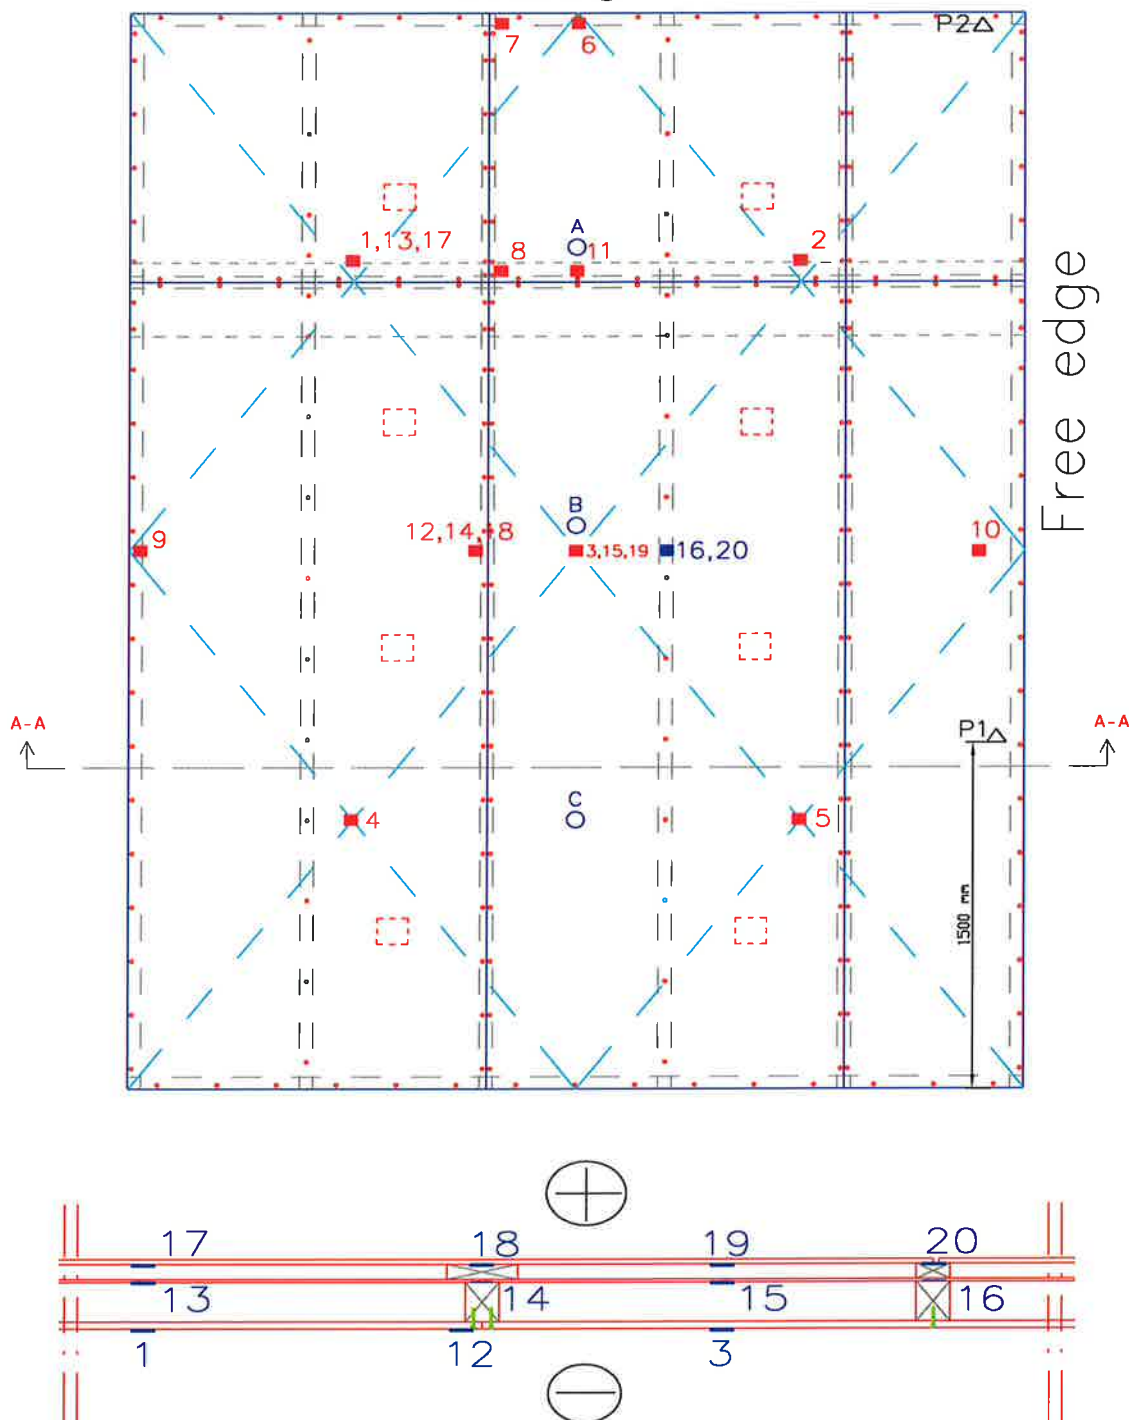
Test arrangement

- tc1...tc5 Average temperature of the unexposed surface
- tc1...tc12 Max temperatures on the surface of the test specimen
- tc13-16, 18-20 Temperature inside the test specimen (informative)
- Deflection of the test specimen
- Furnace temperature
- △ P1, P2 Pressure difference between the furnace and the test hall
- Horizontal joints behind the first layer on the unexposed side

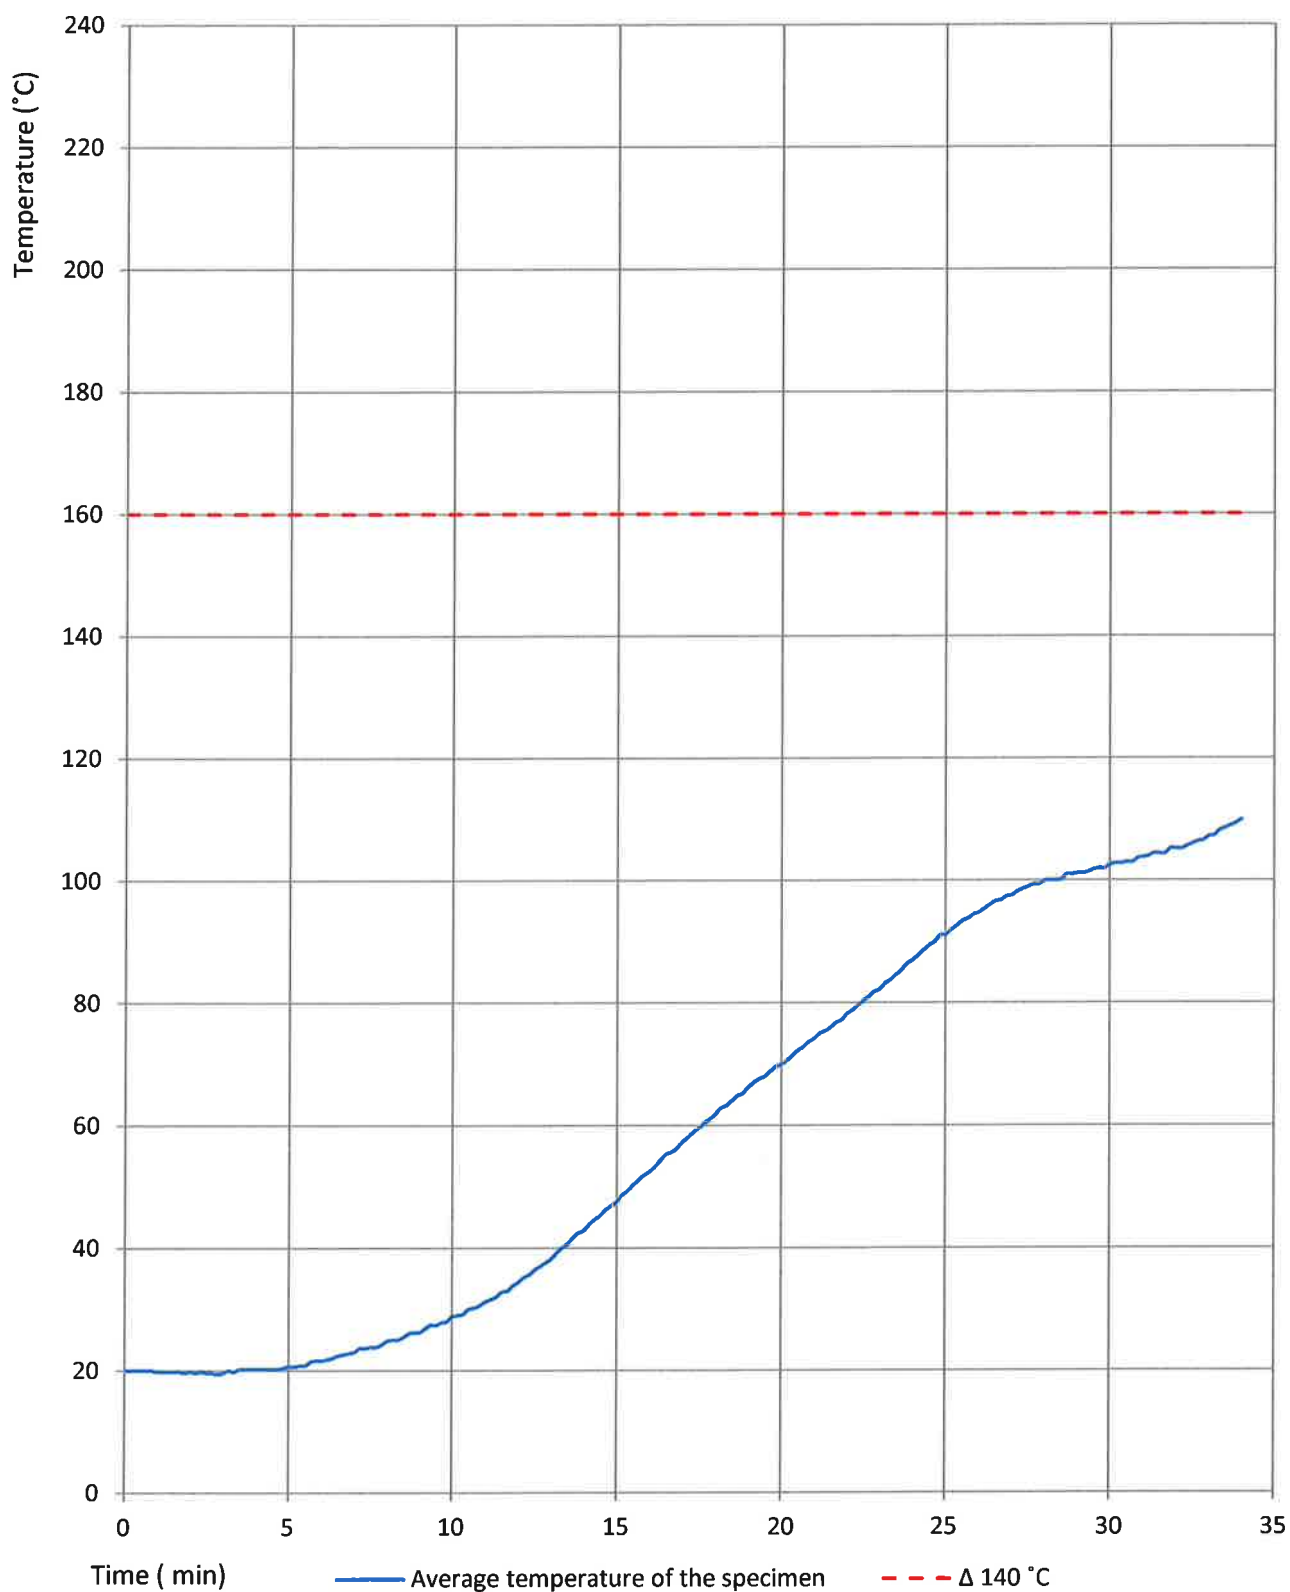
Figure 1. Measured specimen temperature. Mean of thermocouples tc1...tc5

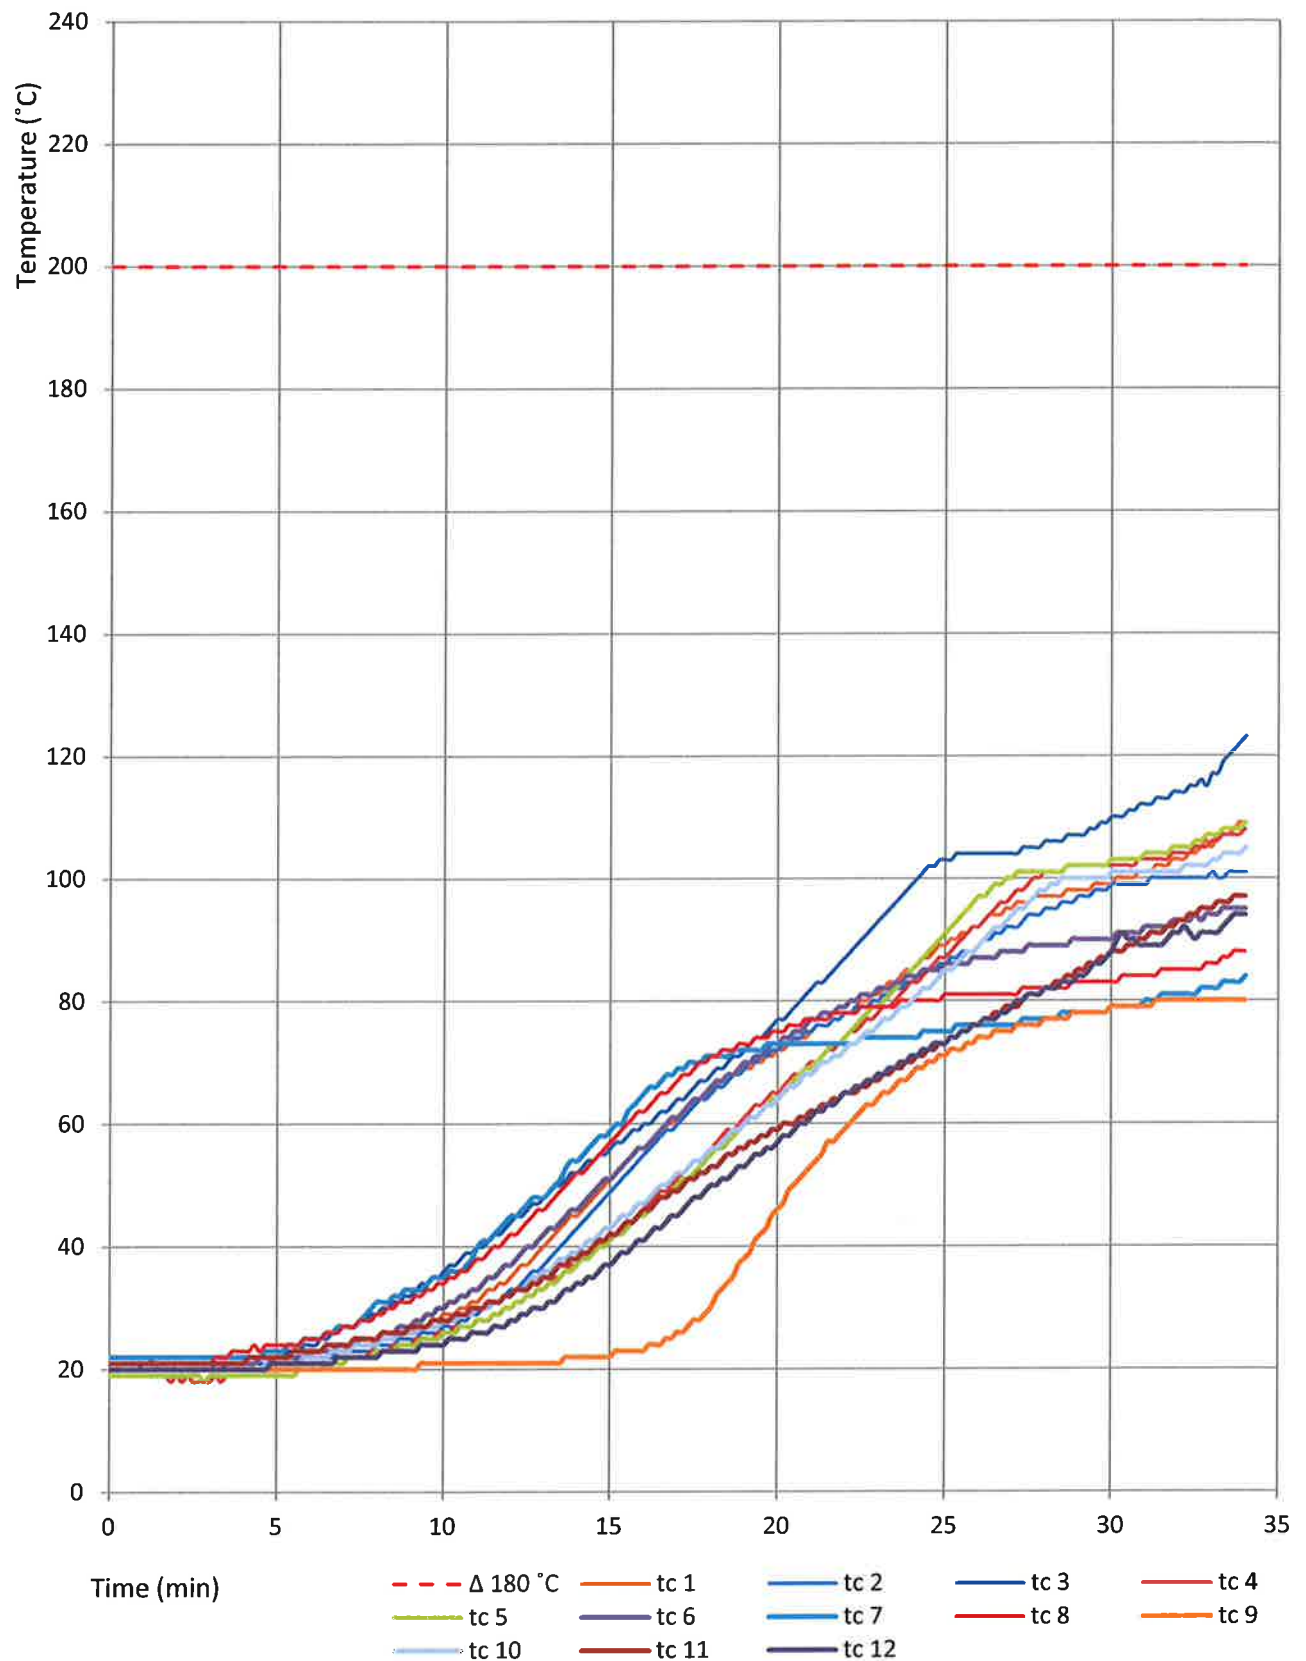
Figure 2. Measured individual specimen surface temperatures

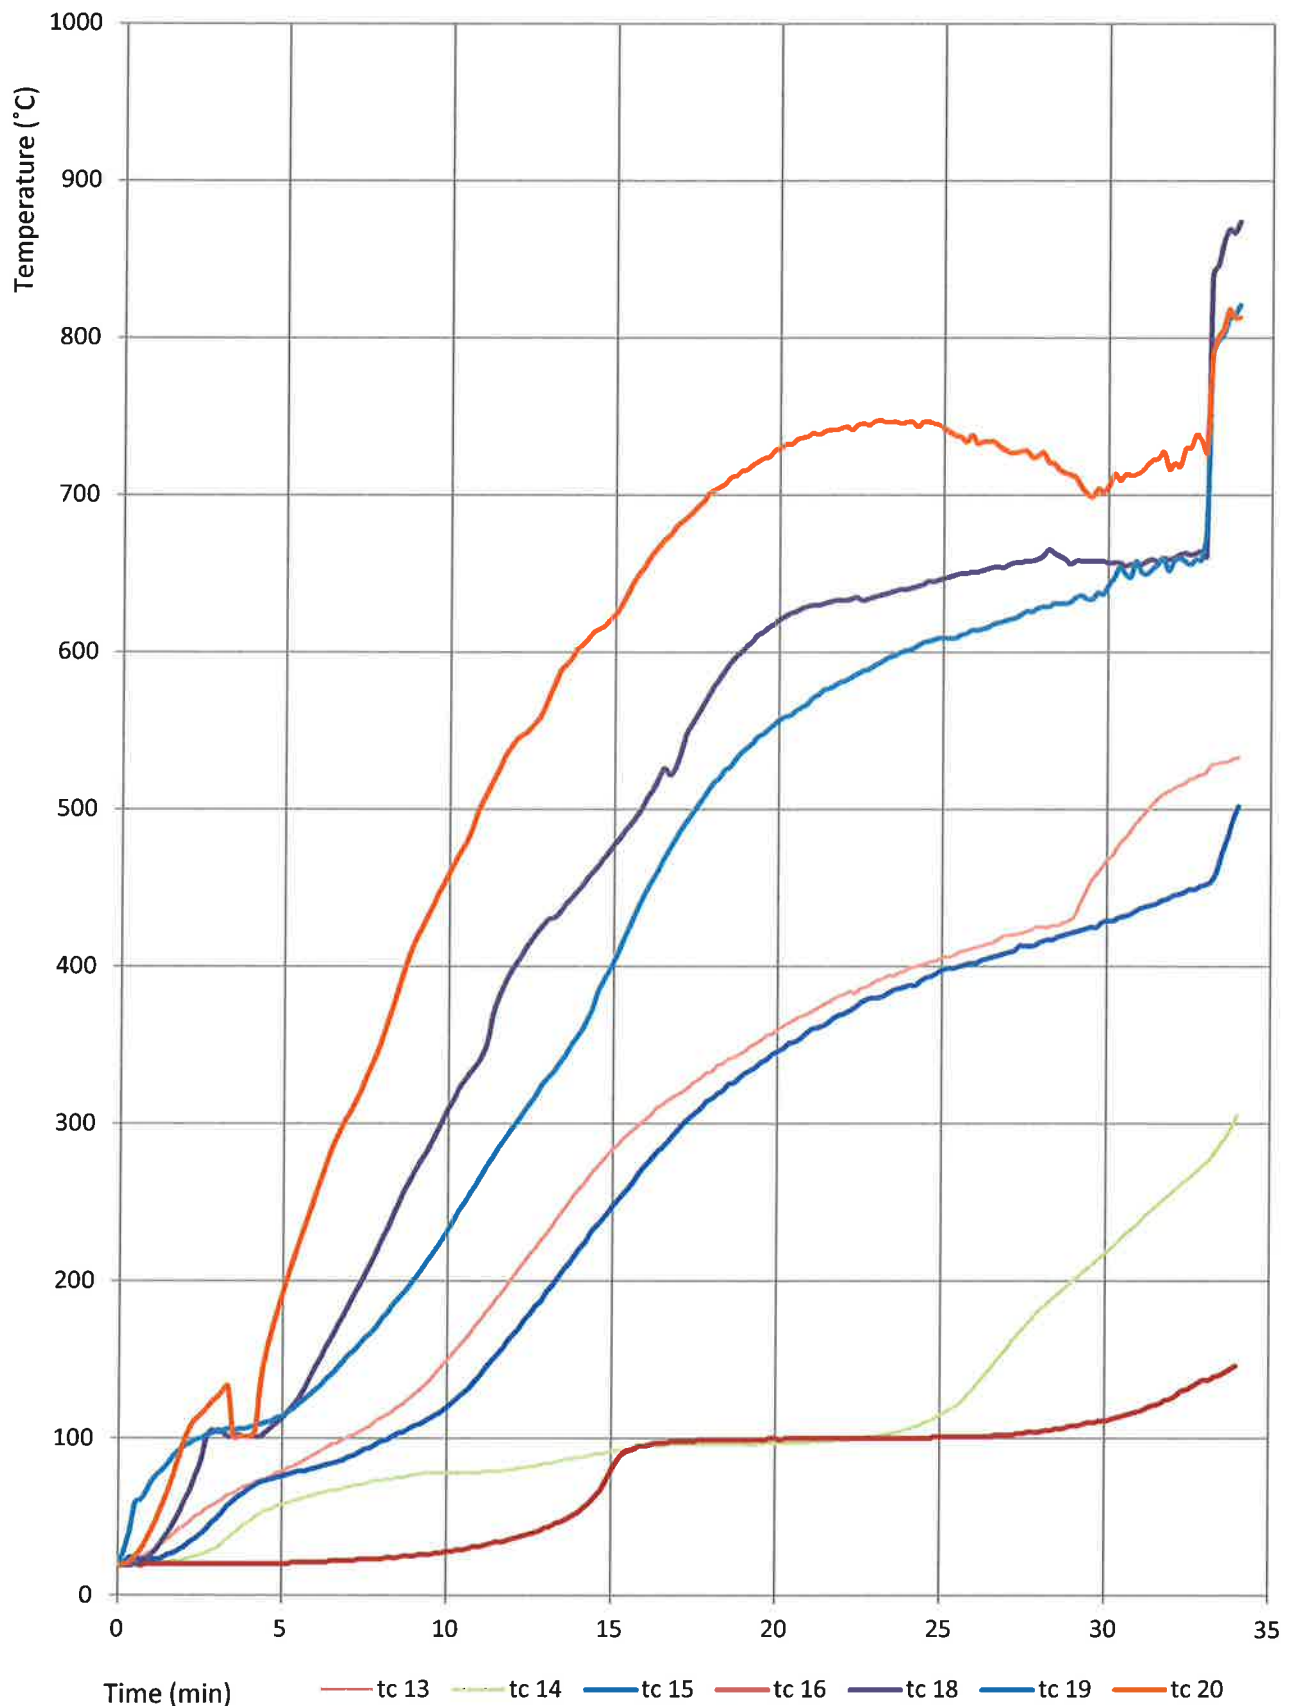
Figure 3. Measured individual specimen temperatures (informative)

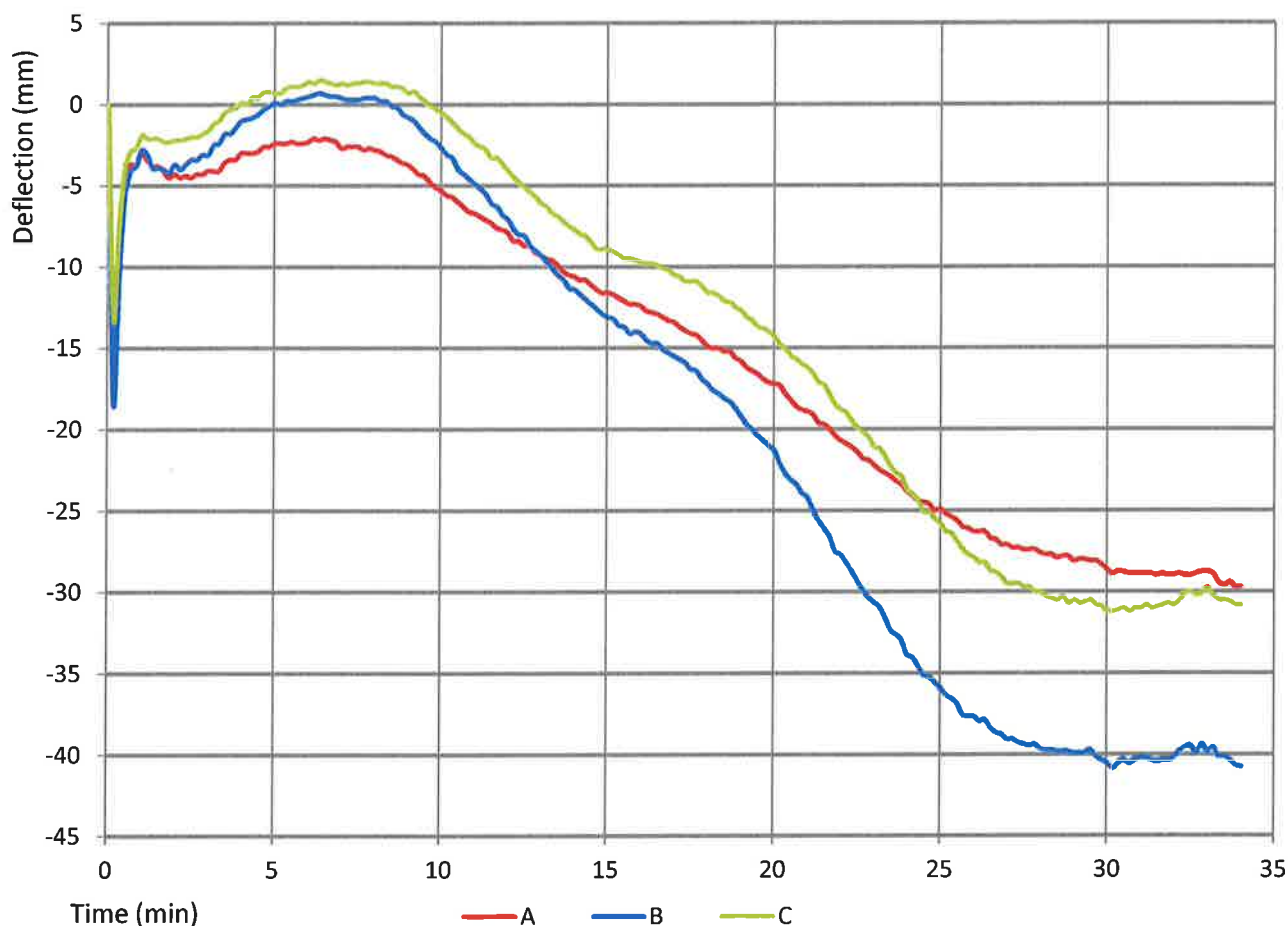
Figure 1. Measured deflections (positive reading is towards the furnace)

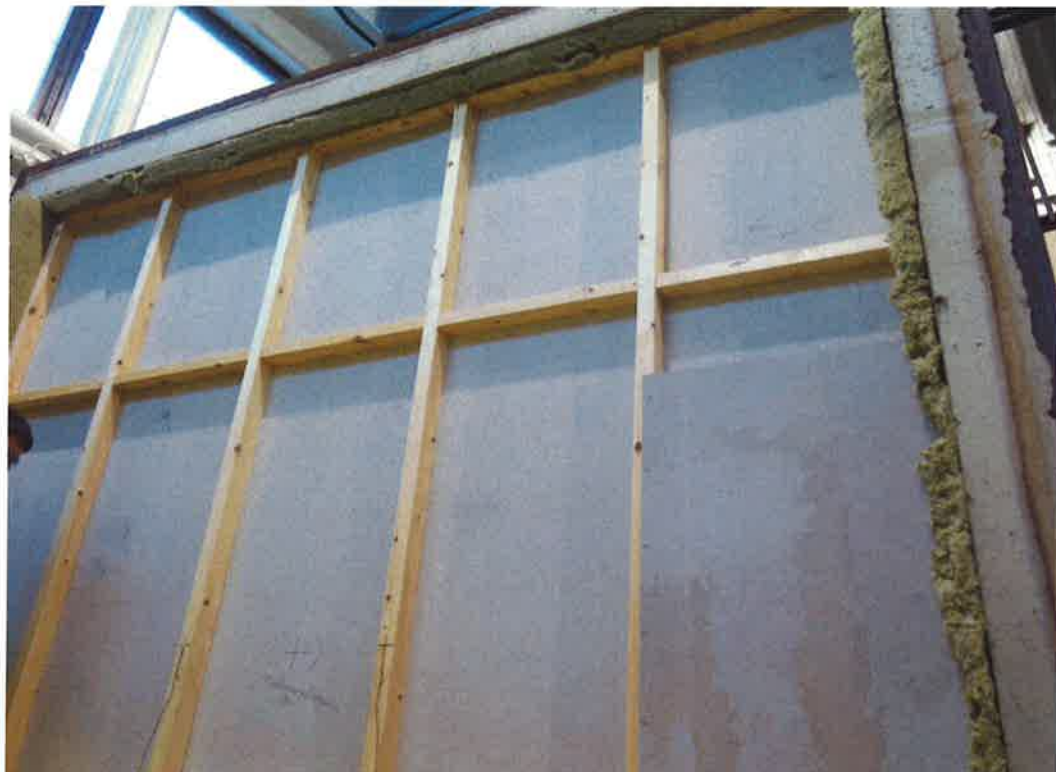
Figure 1. Fixing the wind shield boards on the exposed side of the studs

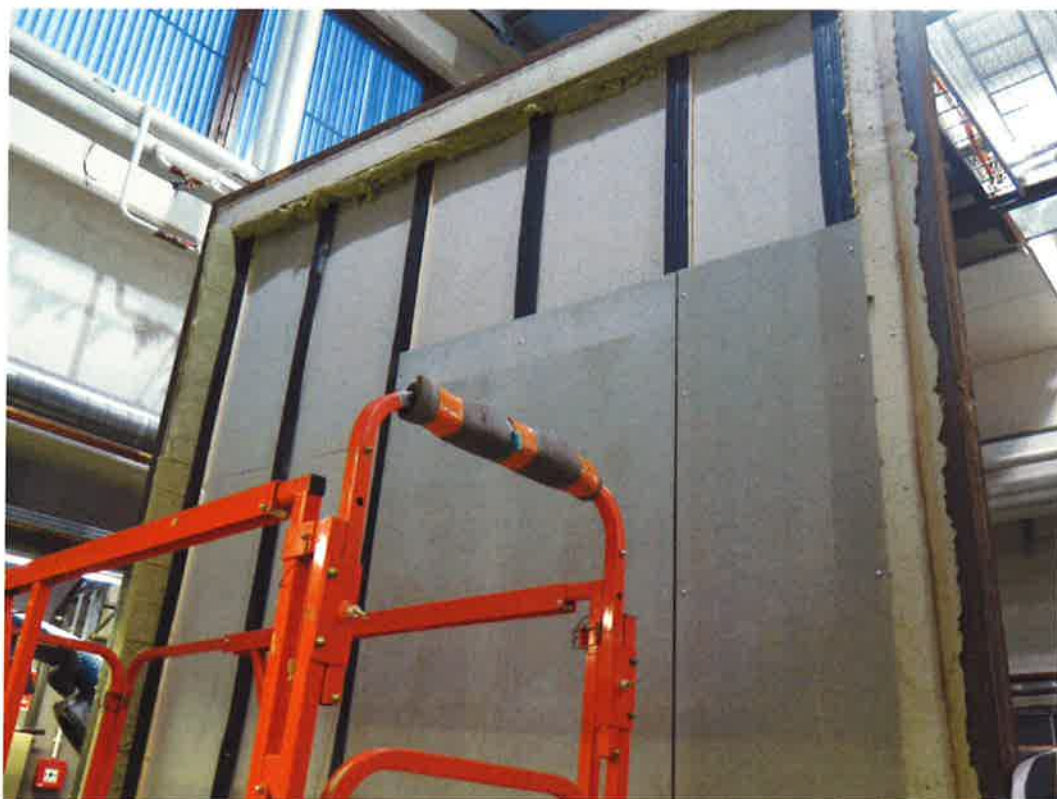
Figure 2. Fixing the façade boards on the exposed side

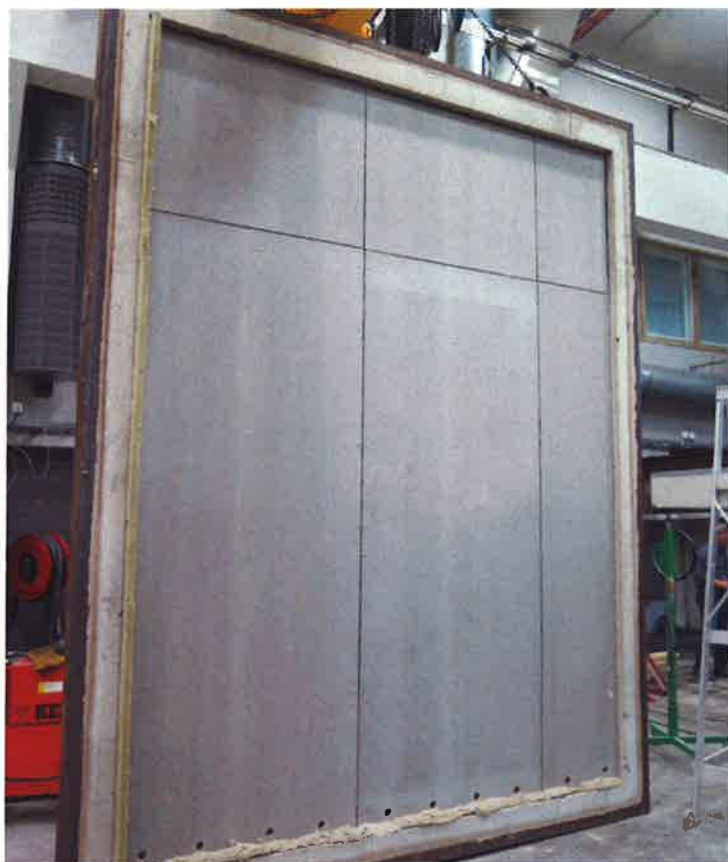
Figure 3. Exposed side of the specimen before the test

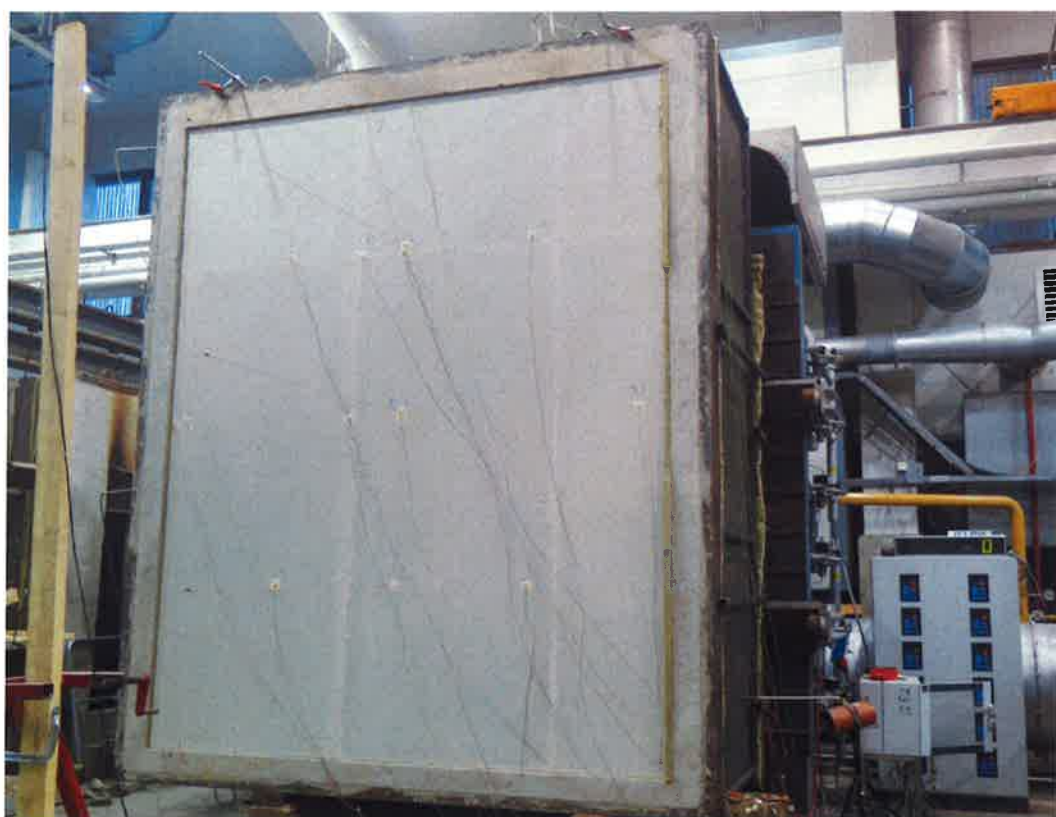
Figure 4. Unexposed side of the specimen before the test

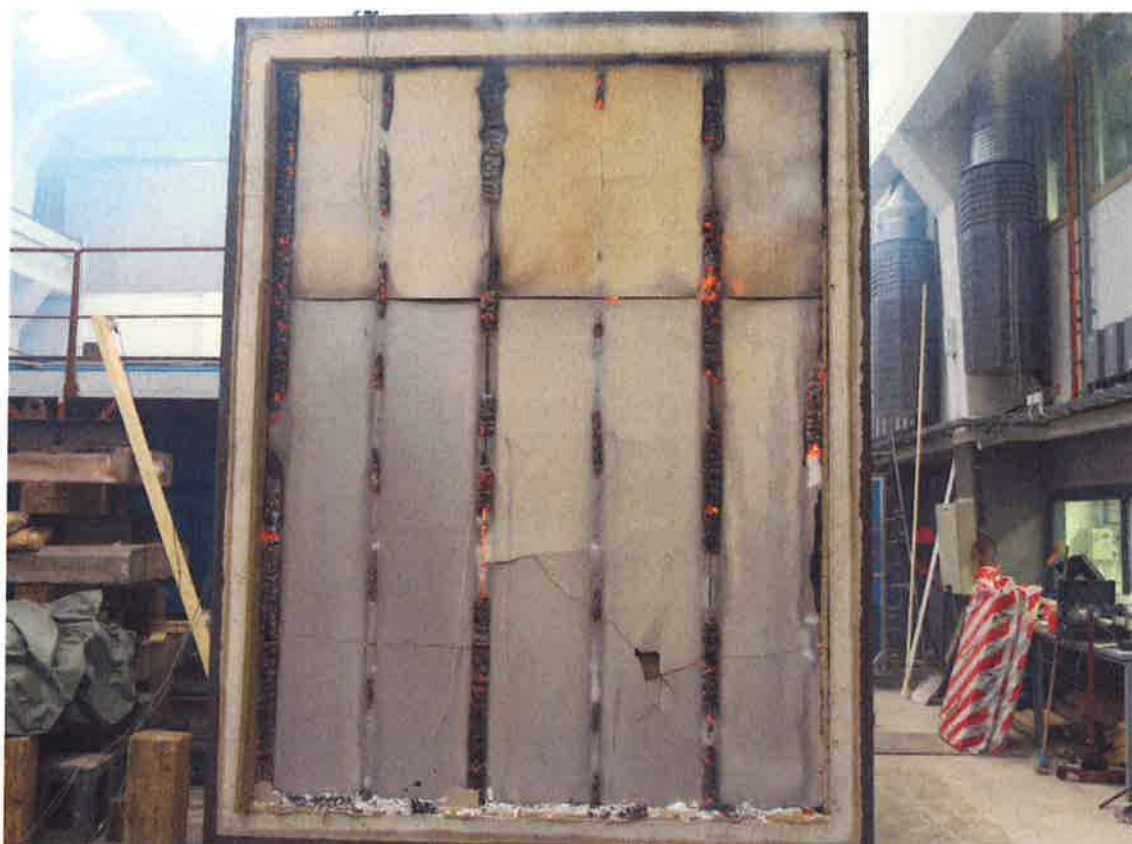
Figure 11. Test specimen after the test
