**Phase II Soil and groundwater
investigation Ter Aar,
the Netherlands**

April 8th, 2010

Reference R001-4707529BKT-beb-V02-NL

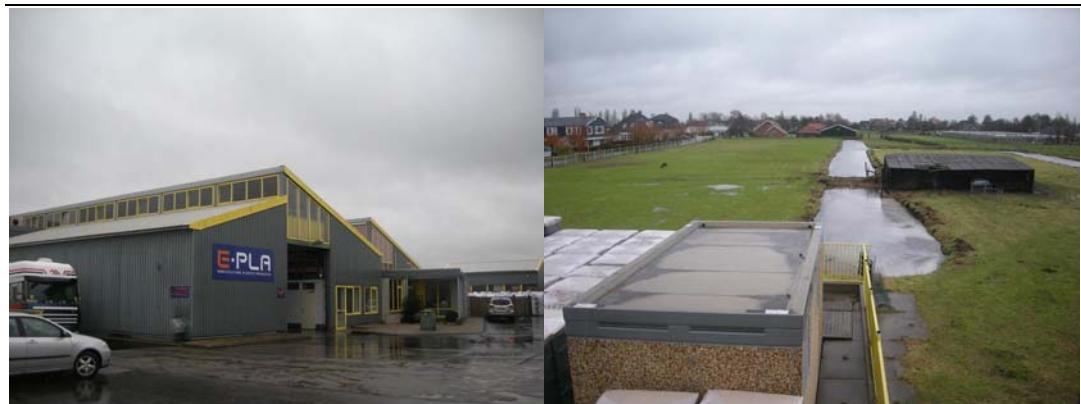
Figures 2.2 and 2.3, left: view to the main production building, right: view to the grassland-east with low shed (sheepfold)

Given the fact that the asbestos is present in a bound compacted product form, and not in free fibre form, there are no health risks anticipated. It is recommended however to properly maintain the roof of the sheepfold as a matter of good housekeeping. Extra costs for the controlled removal of the asbestos containing roof plating will have to be reckoned with in case of demolition of the sheepfold or replacement of the roof. These costs however are not likely to be material.

- It is recommended to properly maintain the roof of the sheepfold as a matter of good housekeeping. Extra costs for the controlled removal of the asbestos containing roof plating will have to be reckoned with in case of demolition of the sheepfold or replacement of the roof. These costs however are not likely to be material

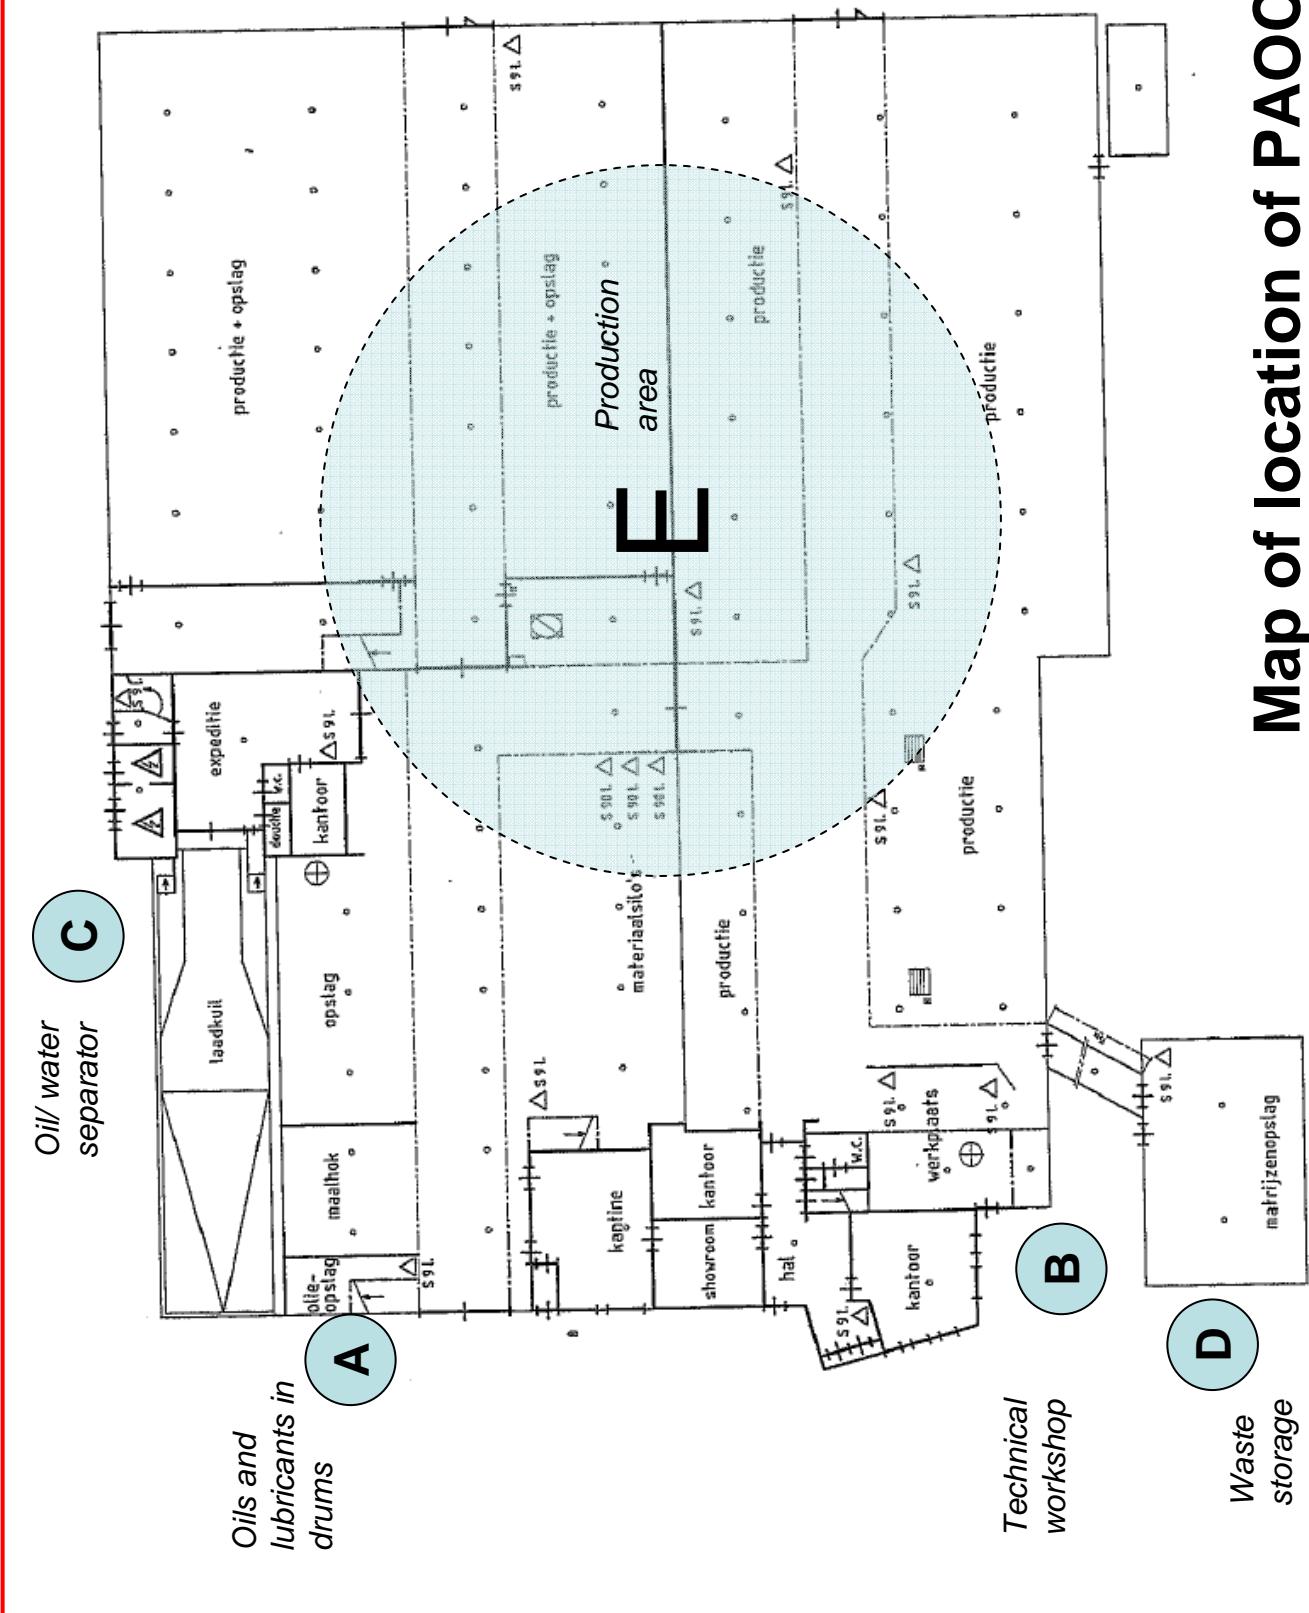
Map of location of PAOCs

- A. Oils and lubricants stored in drums and waste oil storage tank, located indoors on concrete flooring (about 20 m²)
- B. Technical workshop for maintenance and repairs, located indoors with concrete flooring (about 30 m²)
- C. Oil/water separator, located outdoors
- D. Waste storage facilities, wood and scrap metals containers located outdoors
- E. Production area where oil cooled moulding machines are located on concrete flooring (about 2,000-2,500 m²)

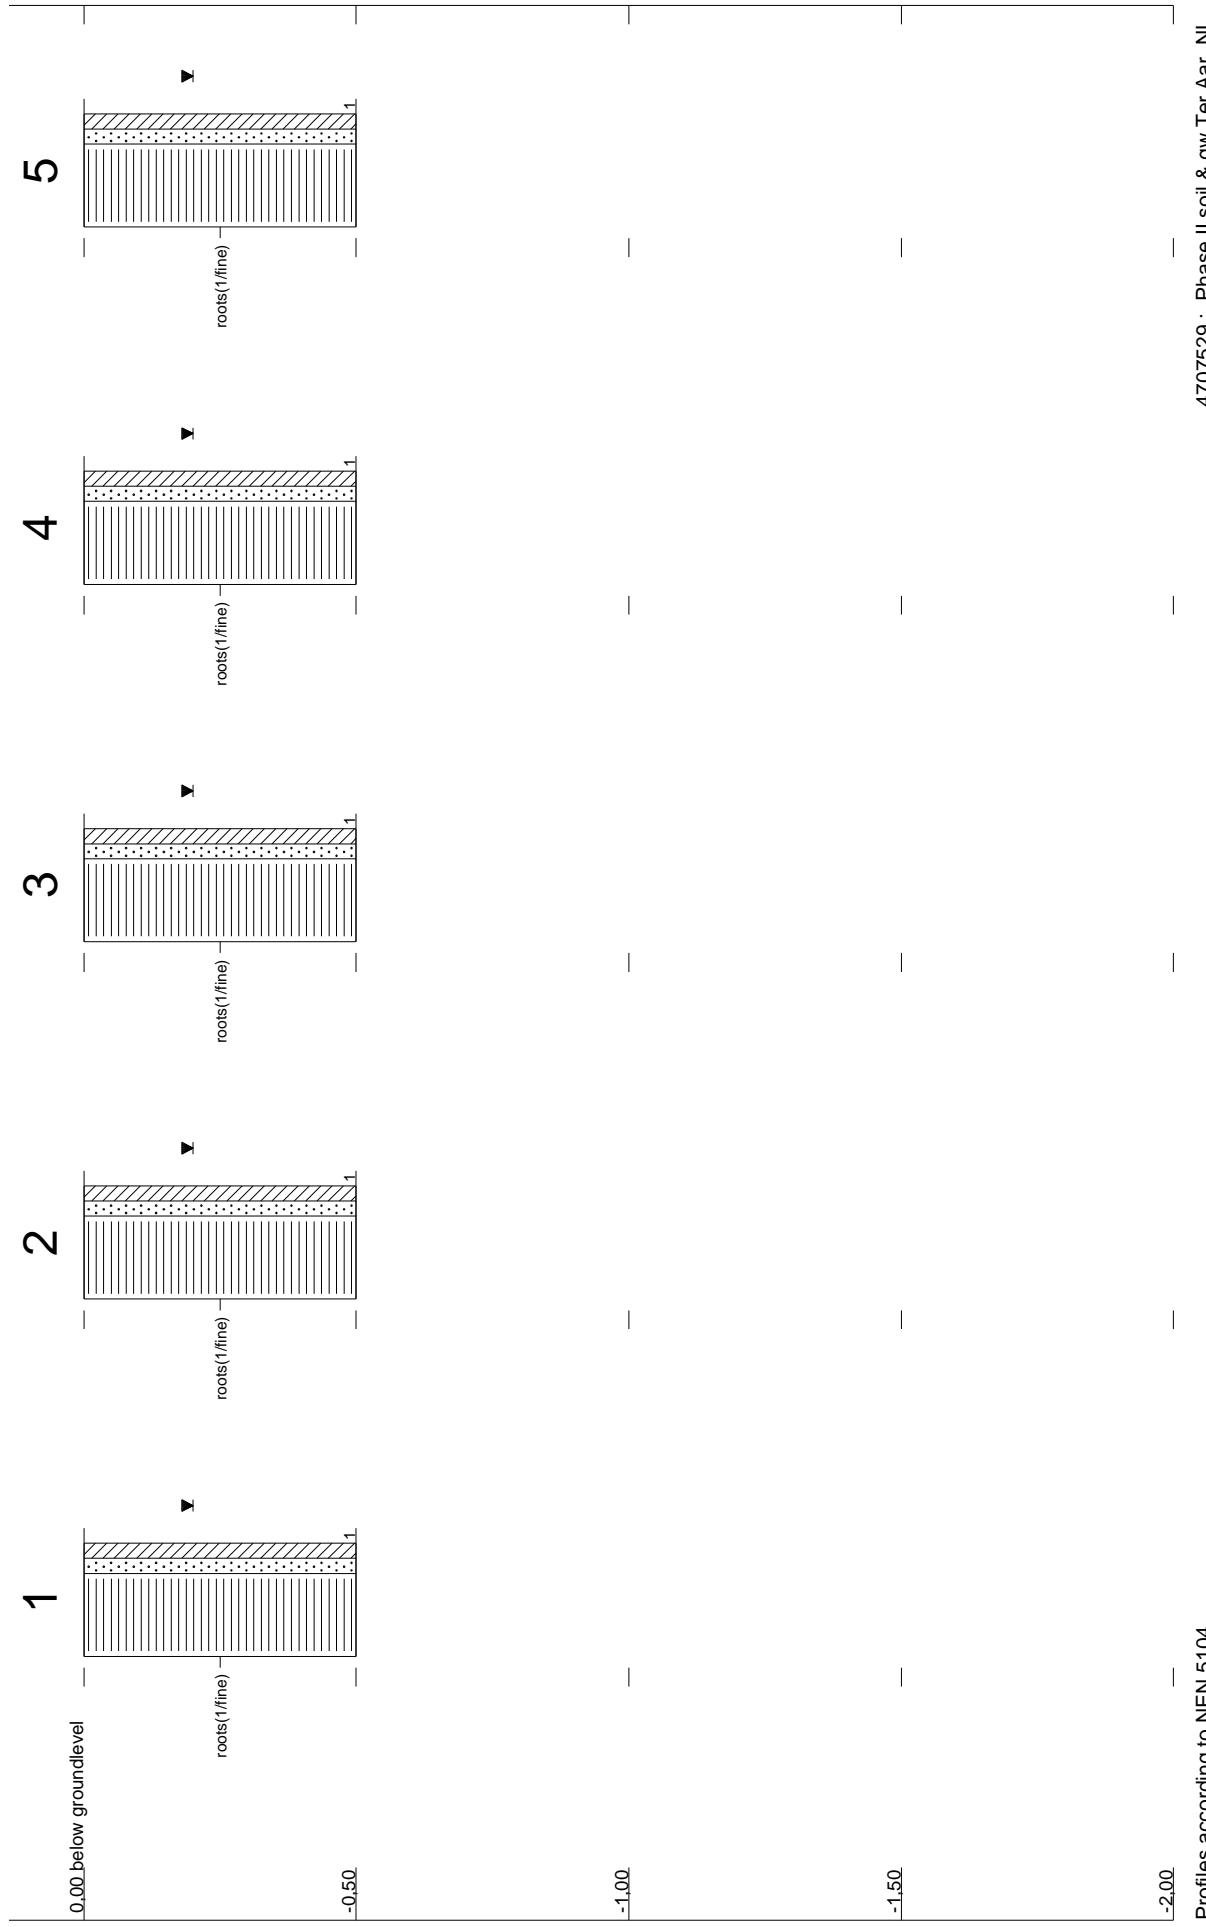
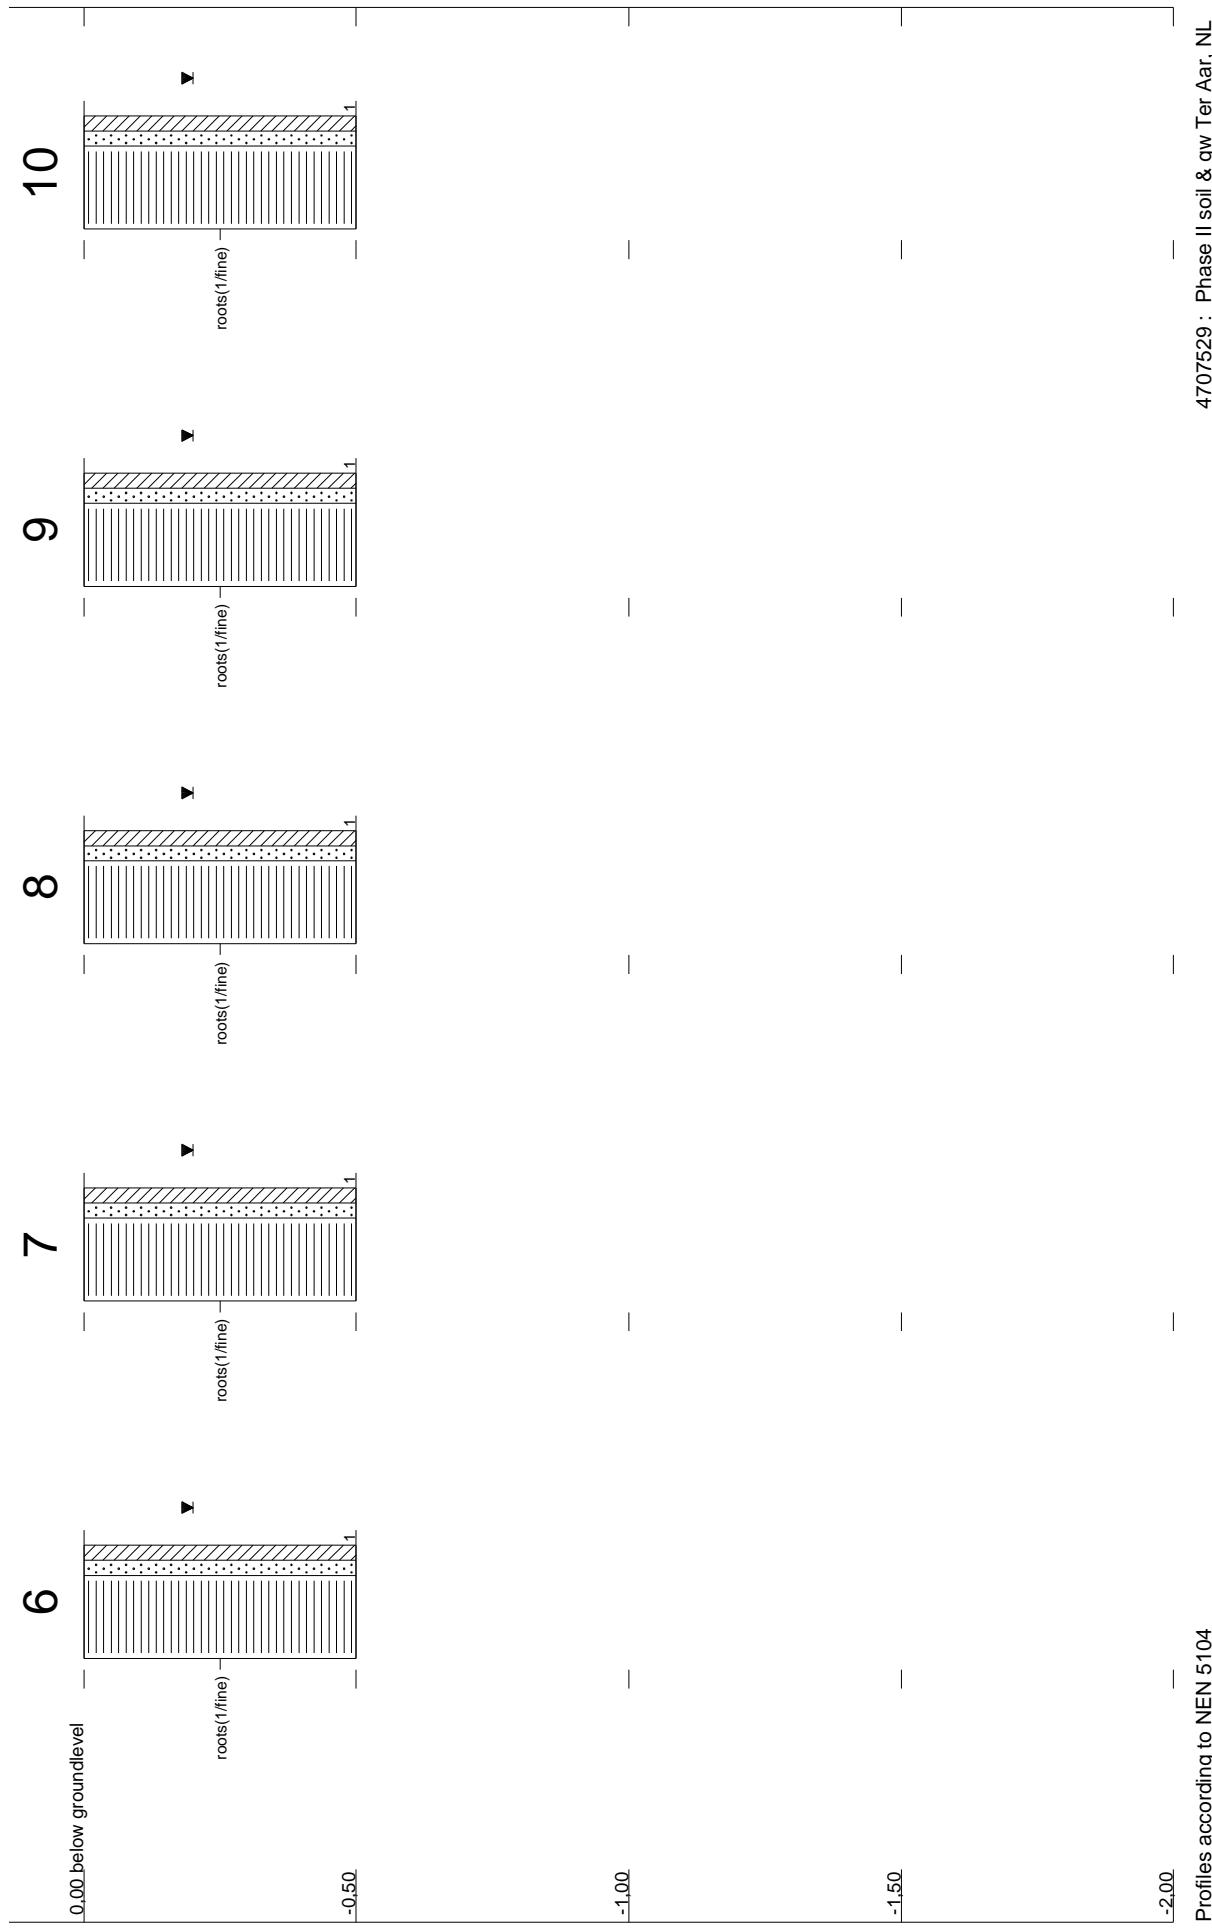
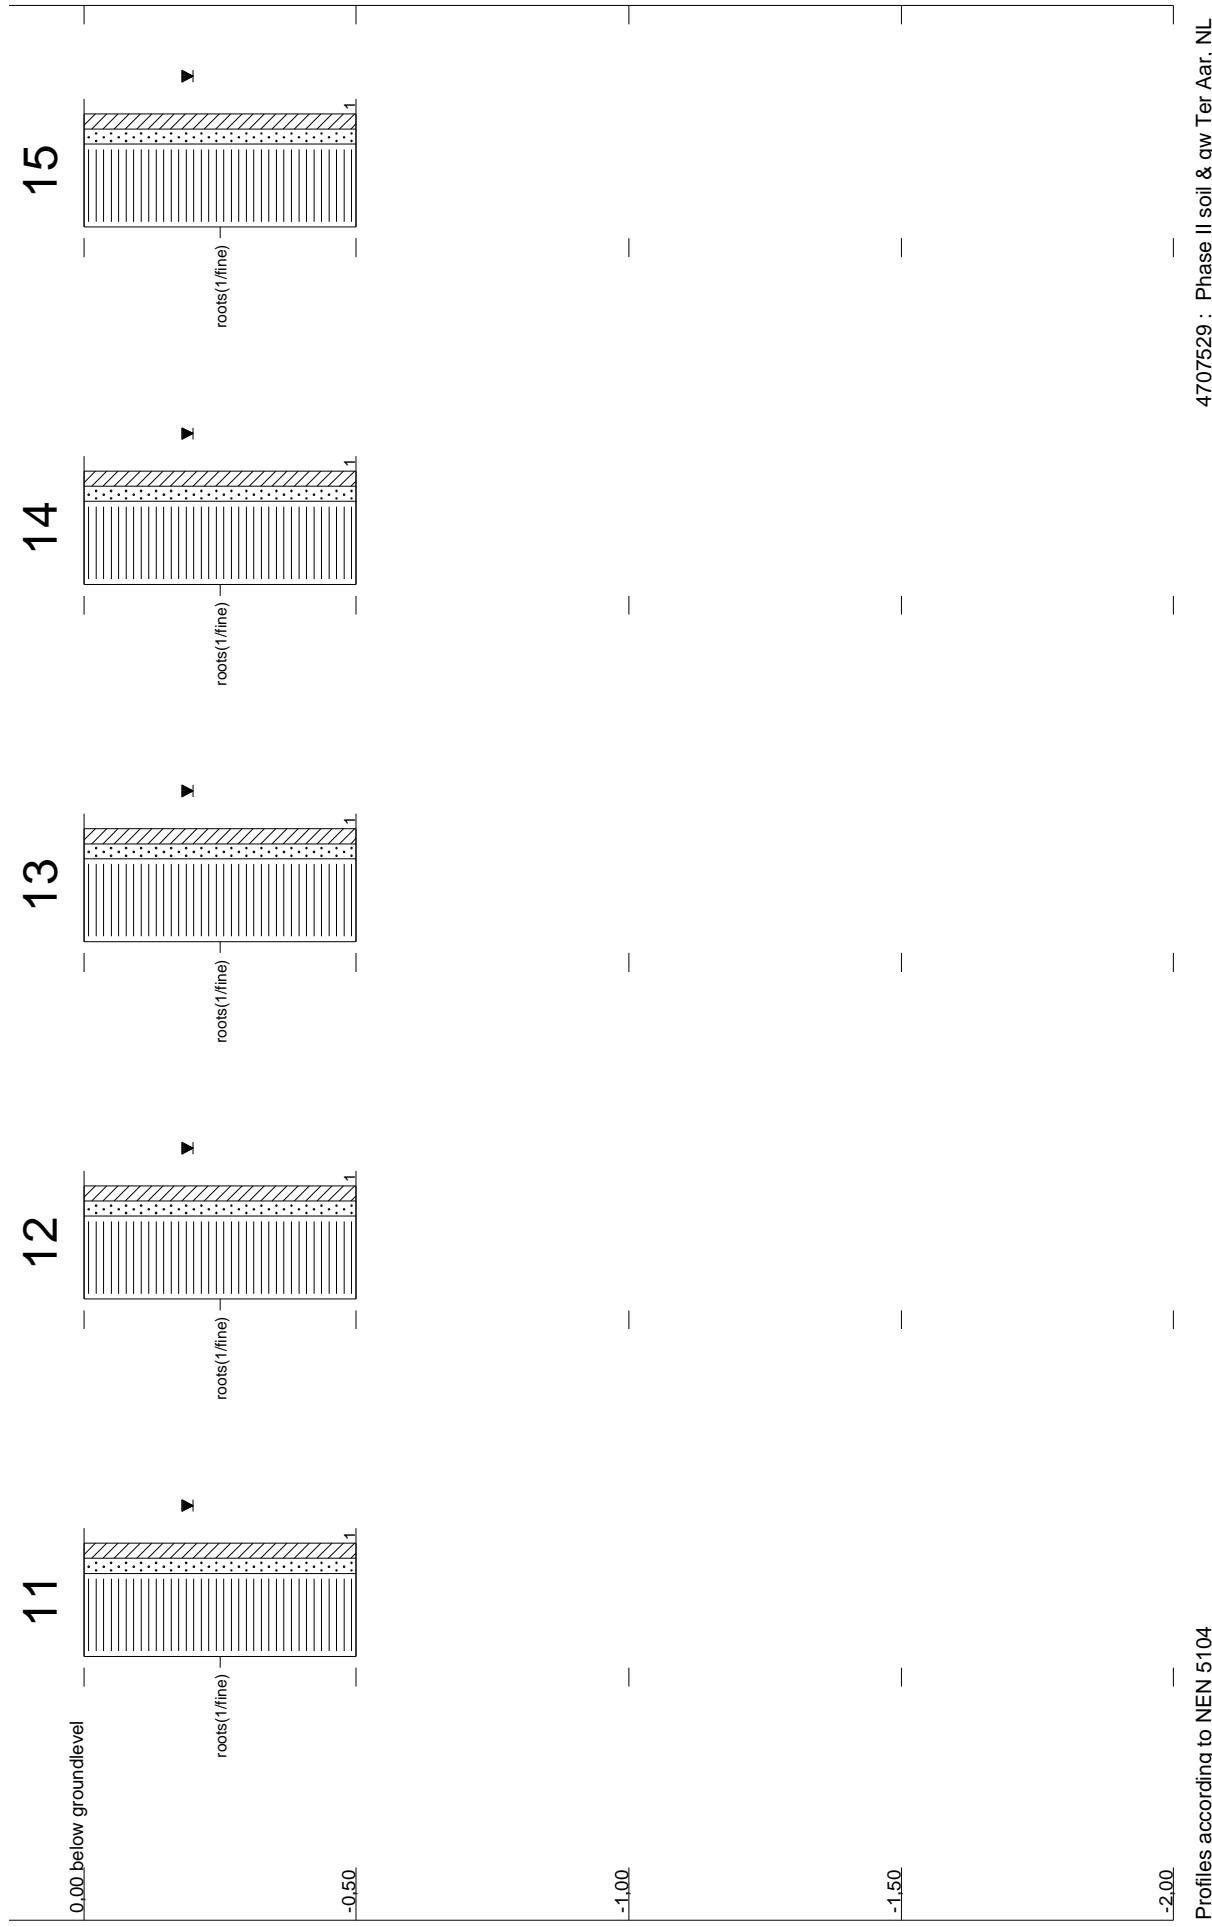
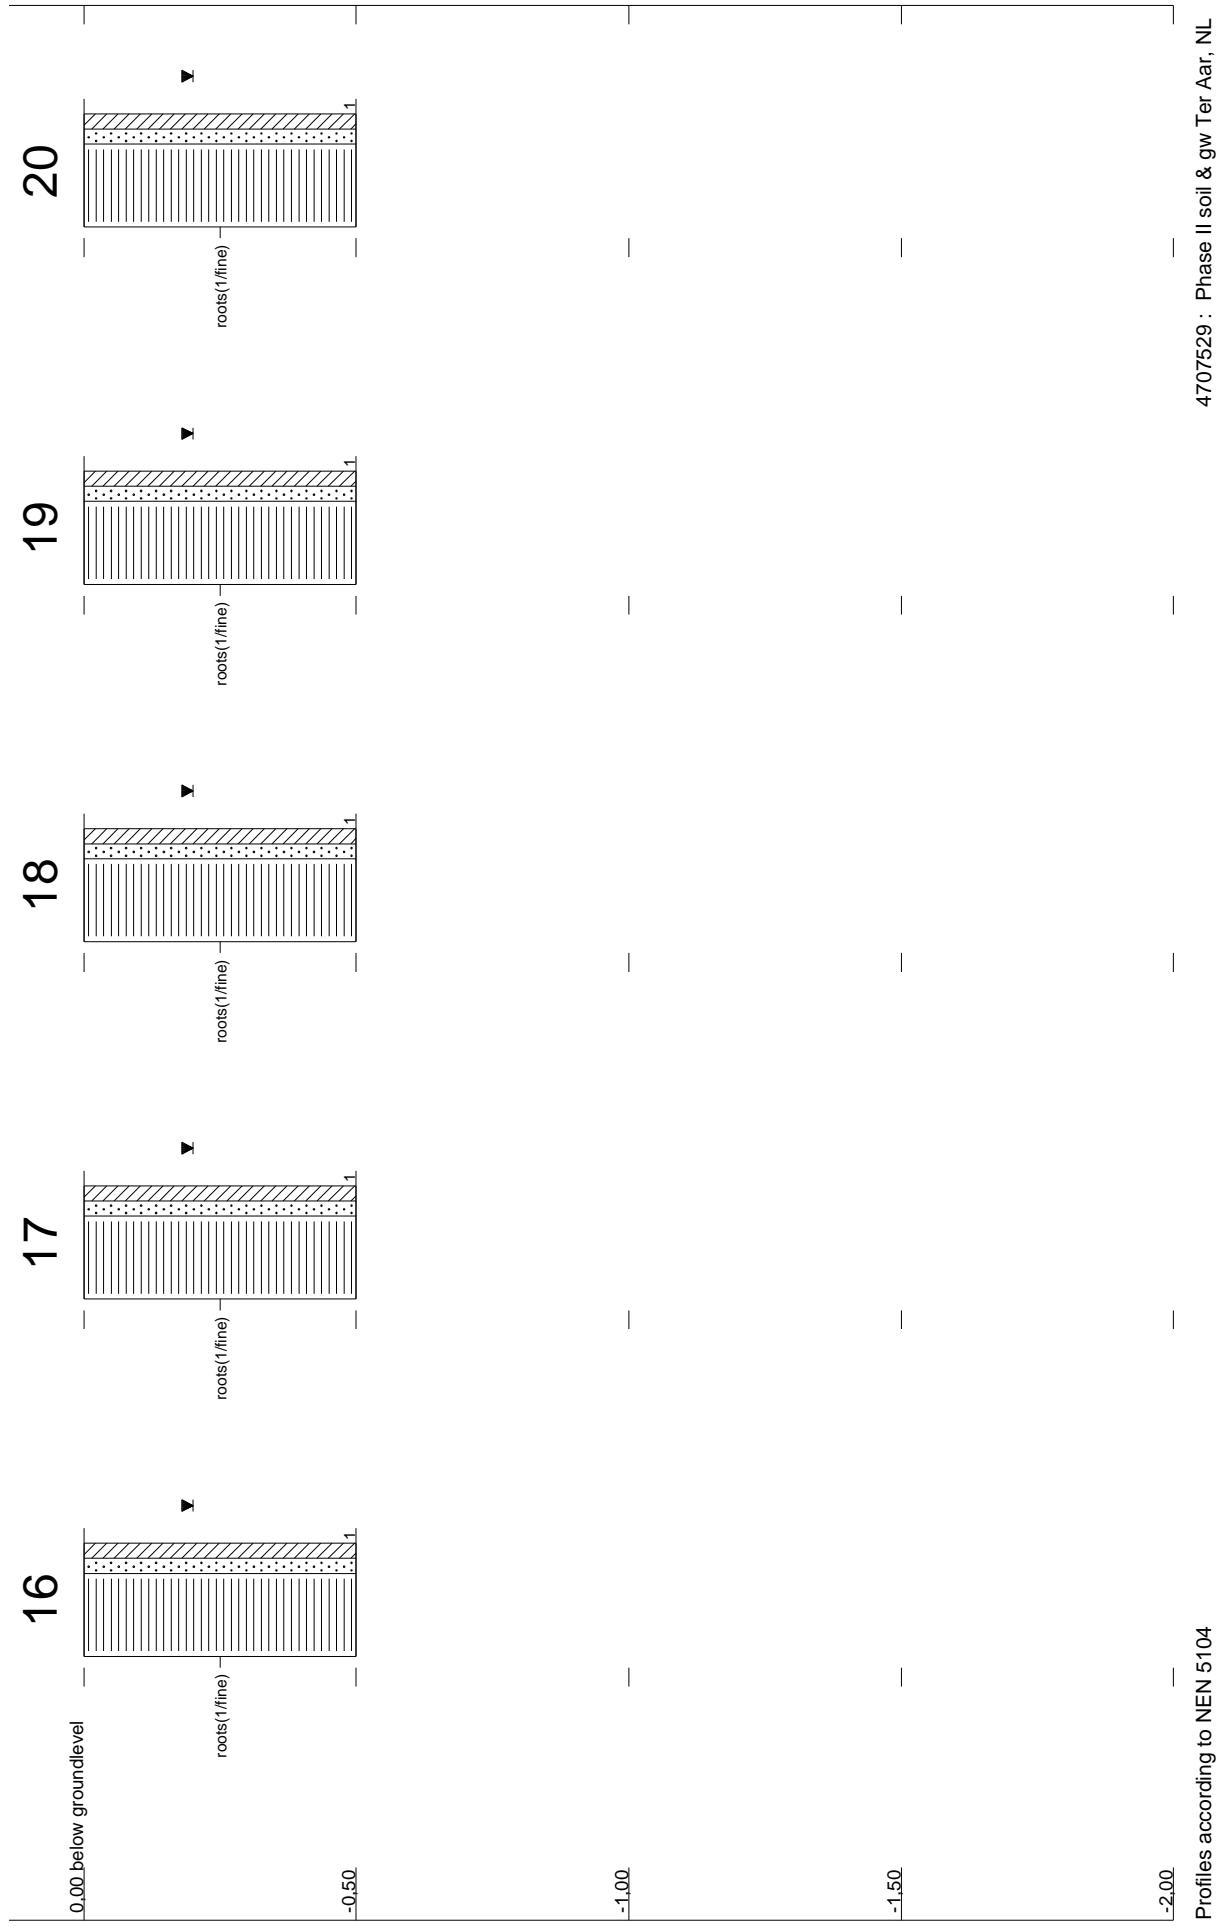
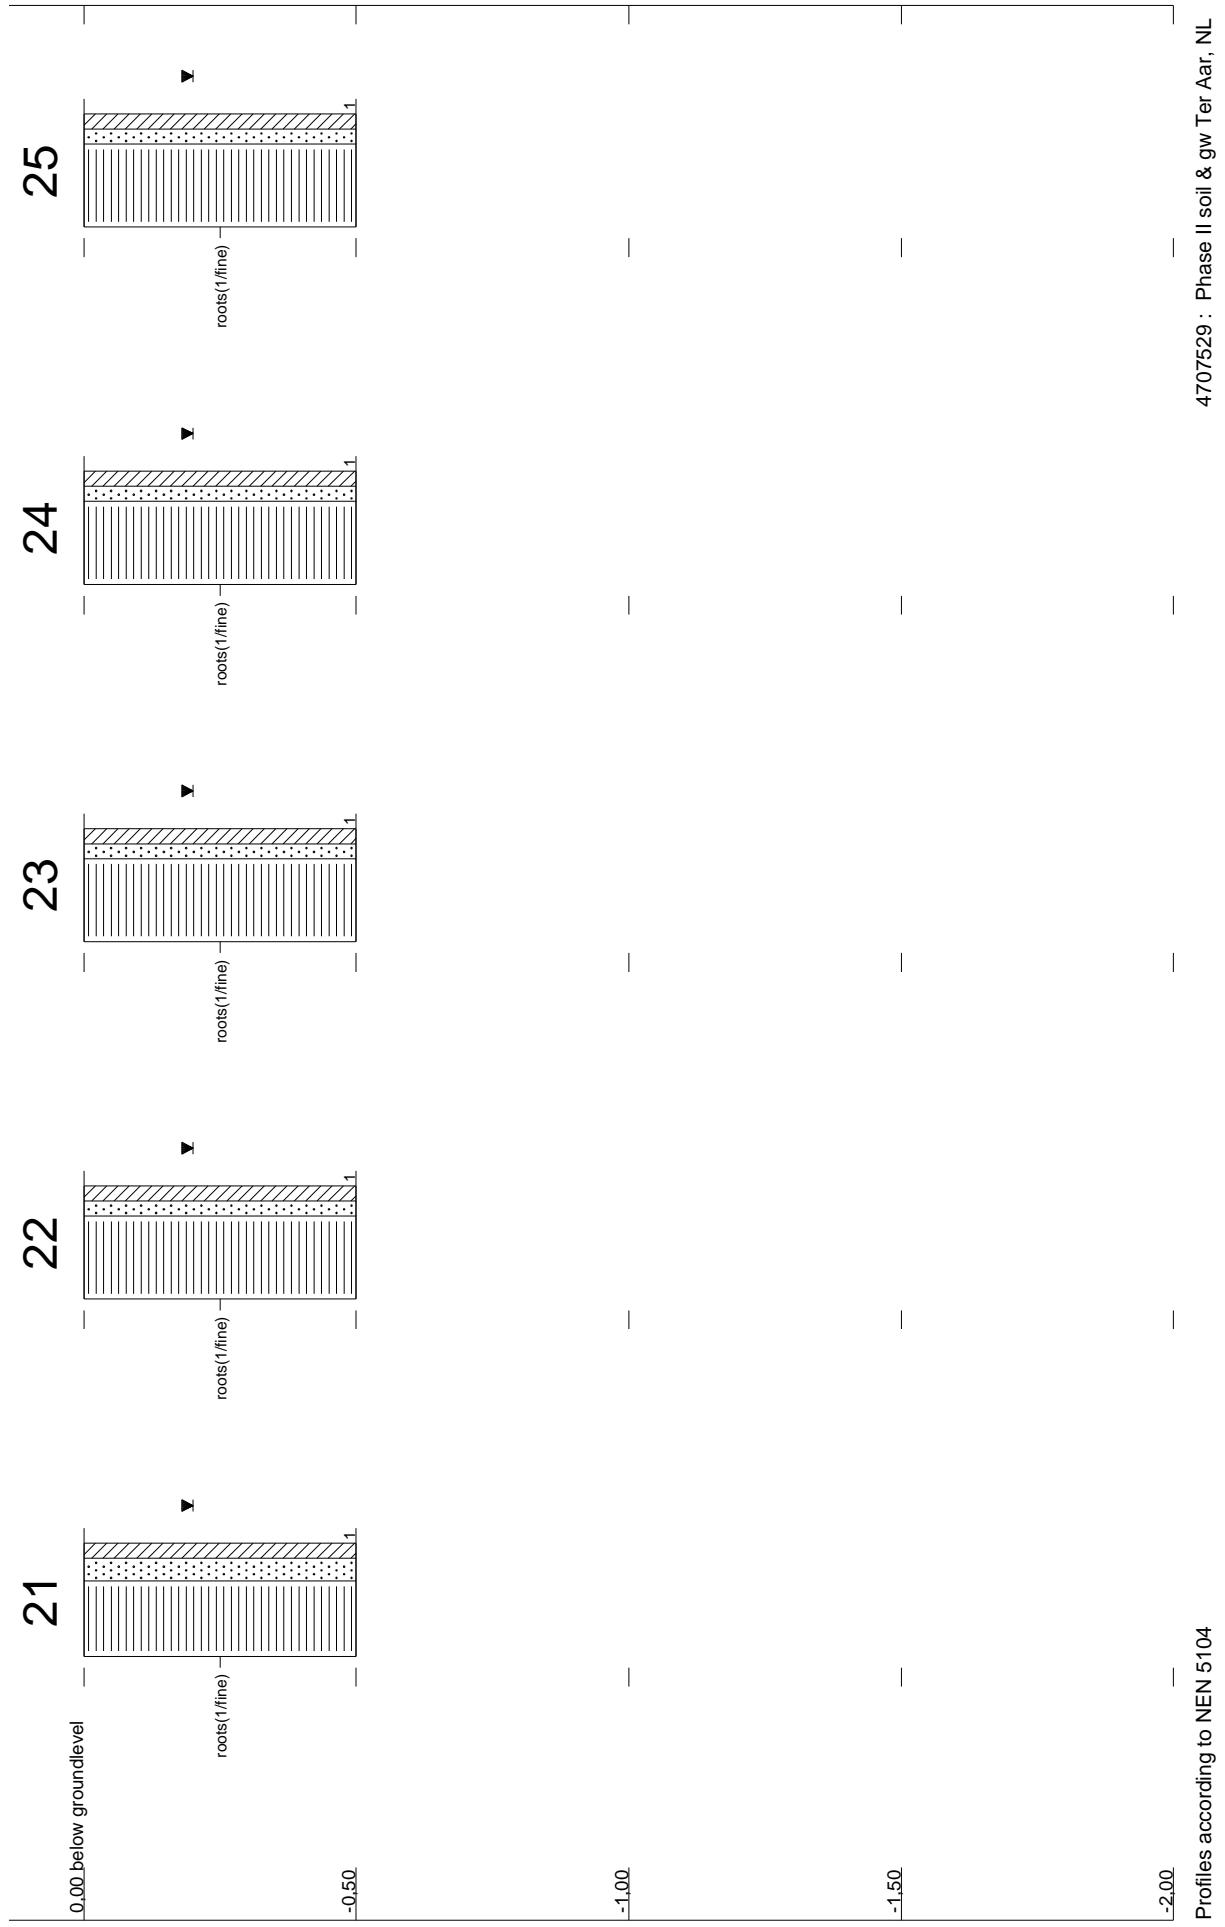
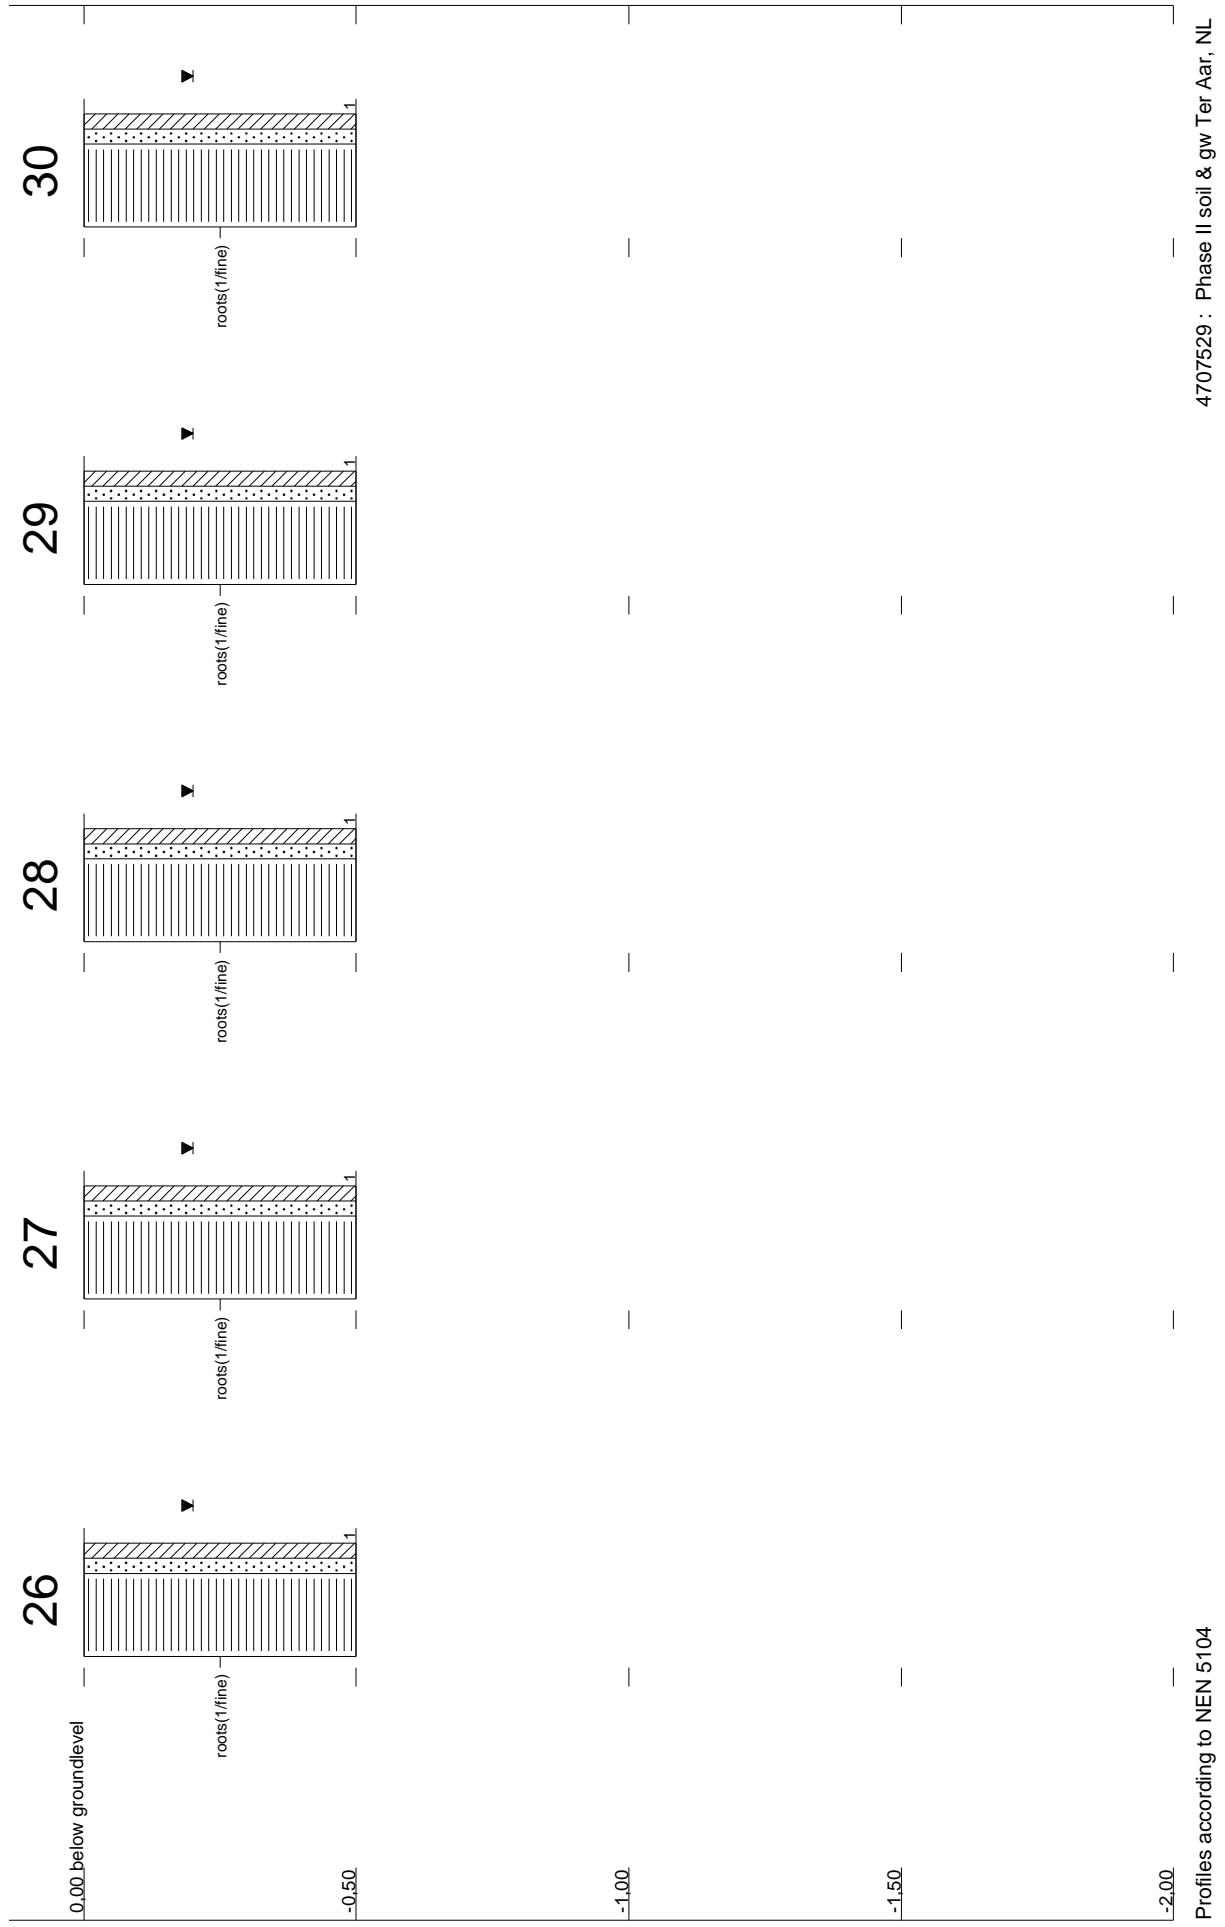
Profiles according to NEN 5104

The soil type at the site to a depth of at least 2 m below ground level (bgl) consists of peat with at some drilling points intermittent sandy layers. Typically root fragments are present in the peaty topsoil, whereas shell fragments are common in the sandy layers. Around the production building rubble (for ground enforcement purposes) is encountered in some drillings to a depth of about 0.8 m bgl.

The soil profile of each borehole was described (see appendix 3) and the different soil horizons were sampled. Individual as well as representative composite soil samples were submitted for chemical analysis to the laboratory. Groundwater observation wells (tube wells) were installed with a one meter filter starting at least half a meter below groundwater level. Groundwater samples were collected one week after installation of the monitoring wells.
